PROPERTY CONDITION ASSESSMENT REPORT

999

Minneapolis Area, MN

Friday, March 6, 2015

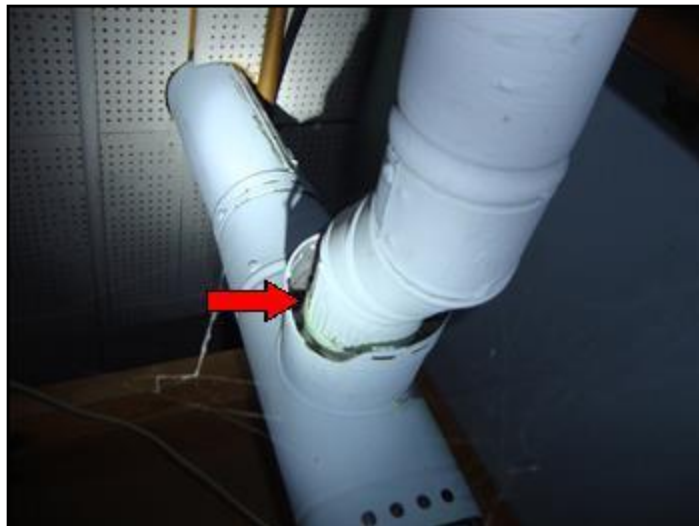
20.

49. Condition: • Poor seal or loose connections at vent connector

Task: Repair

Time: Immediate

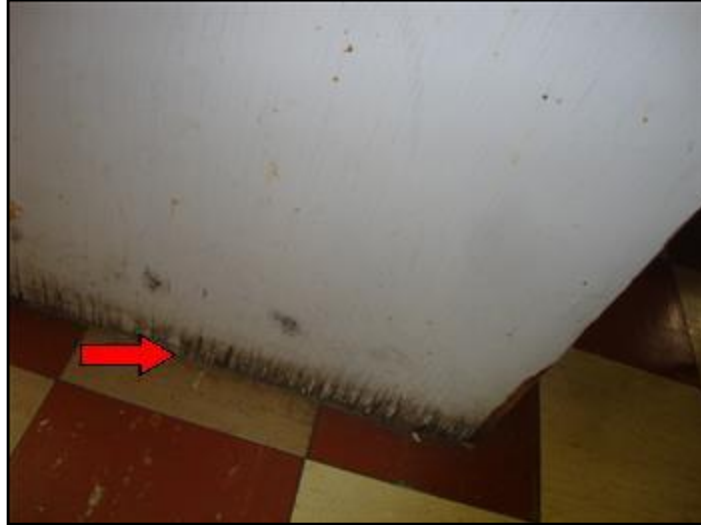
32. *Water damage*

Task: Repair

Time: Discretionary

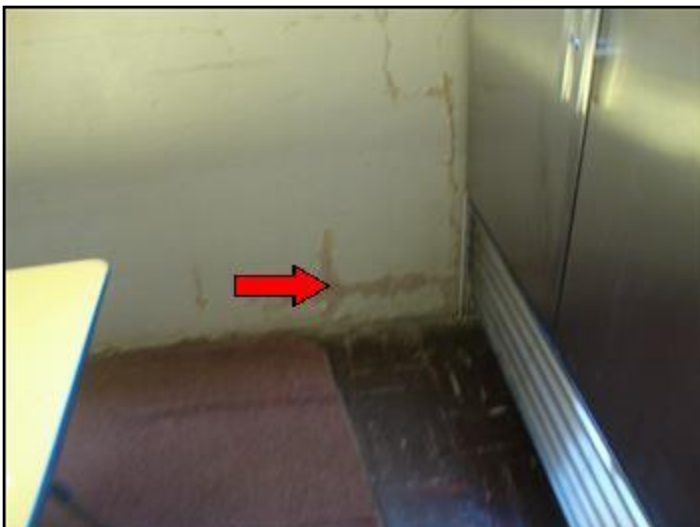
39. Efflorescence

Task: Monitor - Repair

Time: Less than 1 year

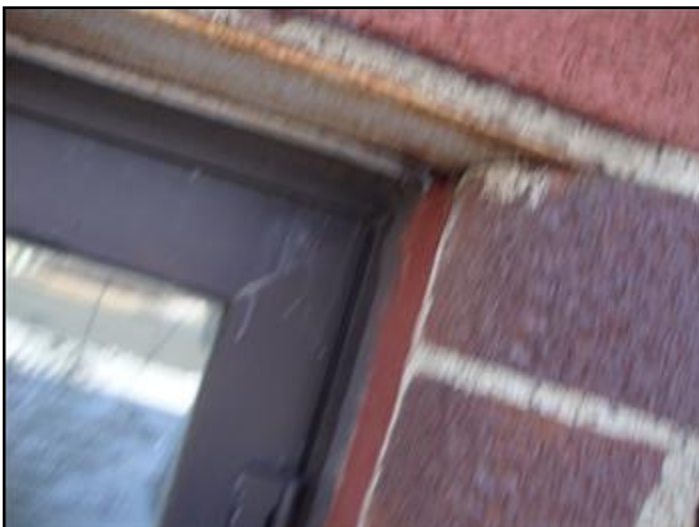
53. Corroded

Task: Service

Time: Less than 3 years

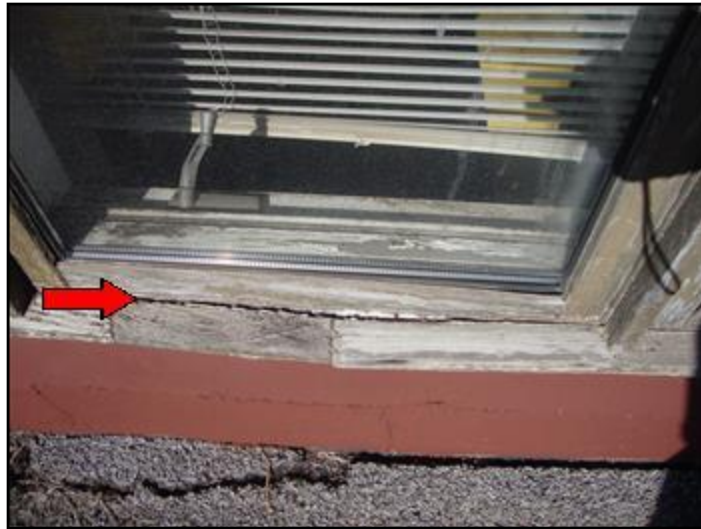
67.

116. Condition: • Old single-glazed, metal-frame
Deteriorated glazing putty.

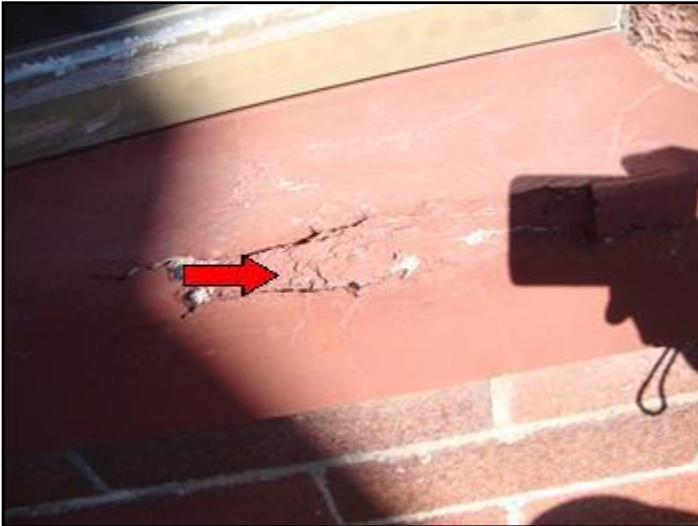
69. Deteriorated

Task: Repair

Time: Less than 2 years

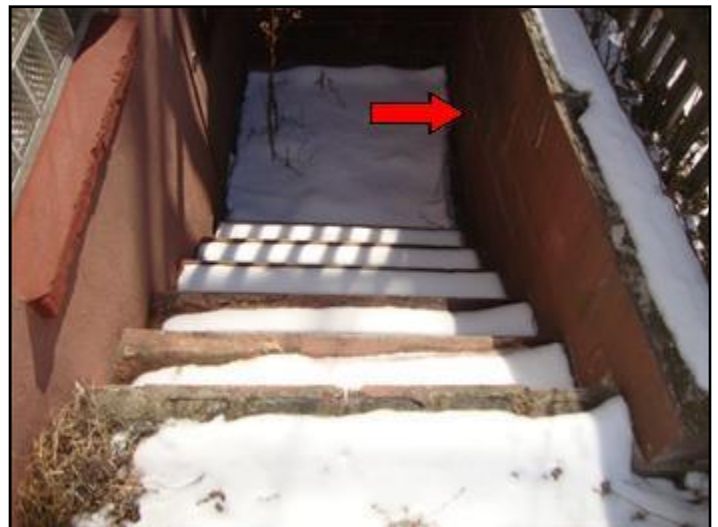
72.

120. Condition: • Missing drain

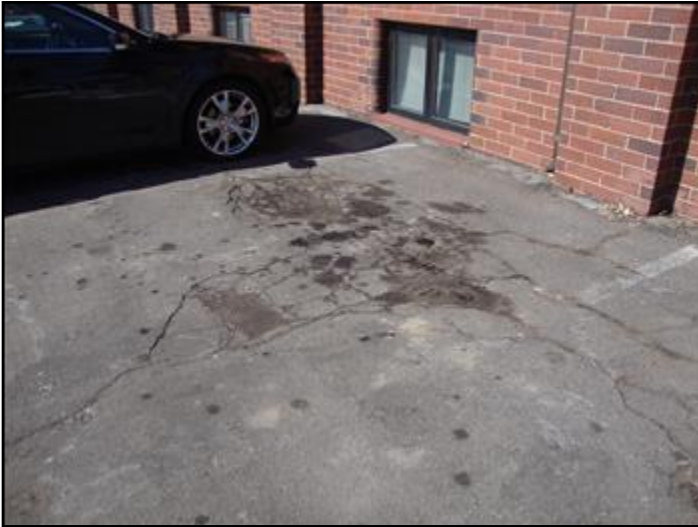
77. Poor overall condition

125. Condition: • Poor overall condition

Several large cracks a surface defects present. Lot slopes to building. A continuous curb is recommended at the south side of the building to divert water to the alley.

Task: Repair or replace
