Home Inspection Report

1234 Main Street
Our Town, Kansas 67890

Prepared for: John Smith

TM Property Inspections LLC
Wichita, Kansas 67226
316-651-0486 or 316-573-2235

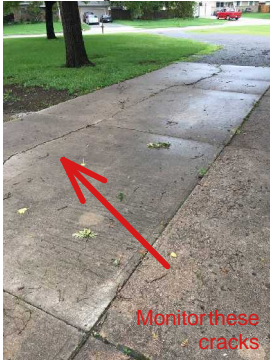
1. ☒ ☐ ☐ ☐ ☐ Driveway: Gravel & Concrete

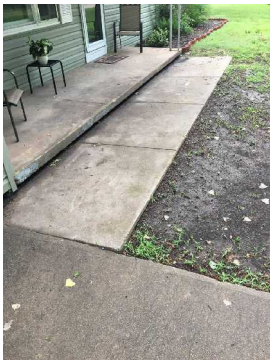
2. ☒ ☐ ☐ ☐ ☐ Walks: Concrete

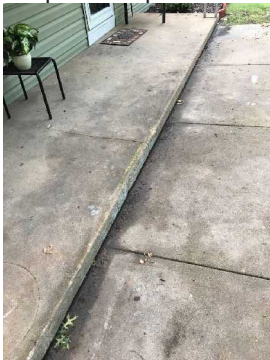
3. ☒ ☐ ☐ ☐ ☐ Steps/Stoops: Concrete

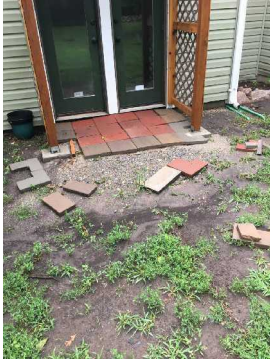
5. ☒ ☐ ☐ ☐ ☐ Patio: Brick

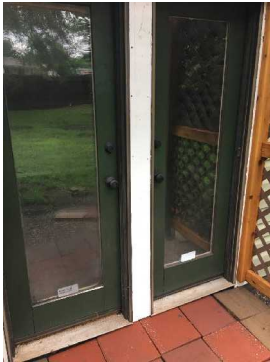
1. ☒ ☐ ☐ ☐ ☐ Type: Vinyl siding
2. ☒ ☐ ☐ ☐ ☐ Trim: Vinyl
3. ☒ ☐ ☐ ☐ ☐ Fascia: Wood
4. ☒ ☐ ☐ ☐ ☐ Soffits: Wood
5. ☐ ☒ ☐ ☐ ☐ Door Bell:
6. ☒ ☐ ☐ ☐ ☐ Entry Doors: Wood
7. ☒ ☐ ☐ ☐ ☐ Patio Door: Double metal doors

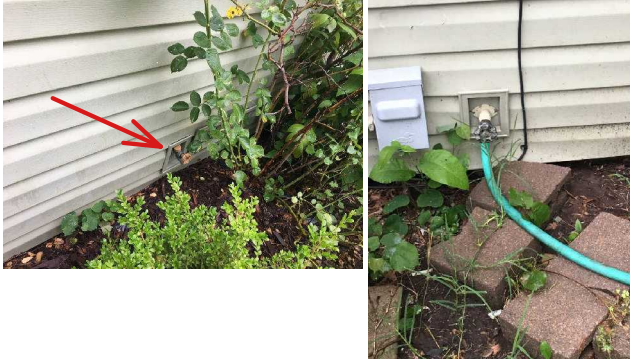
13. ☒ ☐ ☐ ☐ ☐ Hose Bibs: Rotary

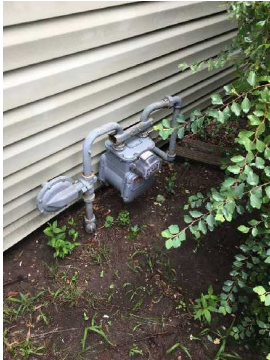
14. ☒ ☐ ☐ ☐ ☐ Gas Meter: South corner of home behind fencing

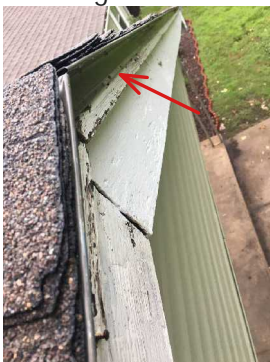
3. Type: Gable with valleys
4. Approximate Age: 5-10 years old
5. ☒ ☐ ☐ ☐ ☐ Flashing: Aluminum

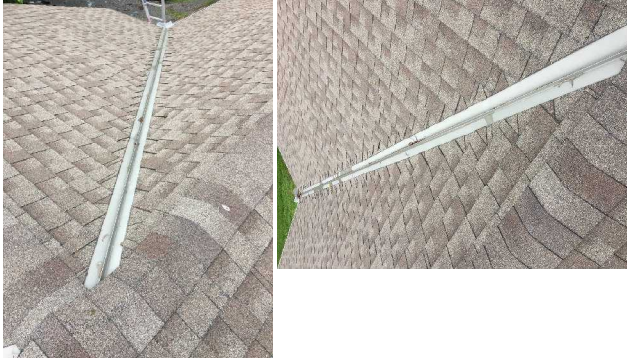
6. ☒ ☐ ☐ ☐ ☐ Valleys: Preformed metal

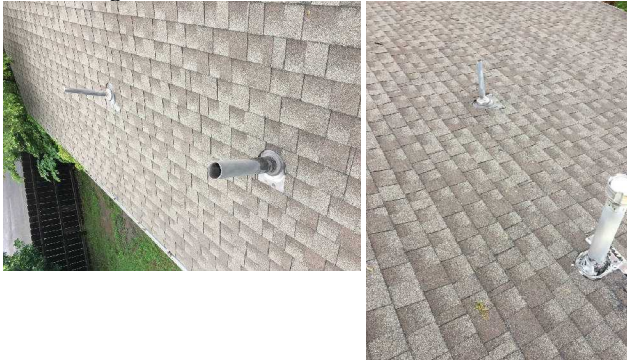
7. ☐ ☒ ☐ ☐ ☐ Skylights:
8. ☒ ☐ ☐ ☐ ☐ Plumbing Vents: Galvanized & PVC

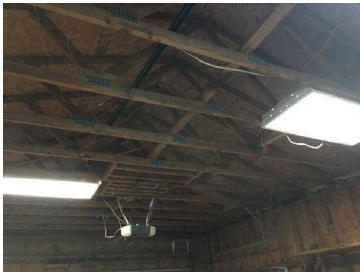
3. ☒ ☐ ☐ ☐ ☐ Roof Structure: Wood truss

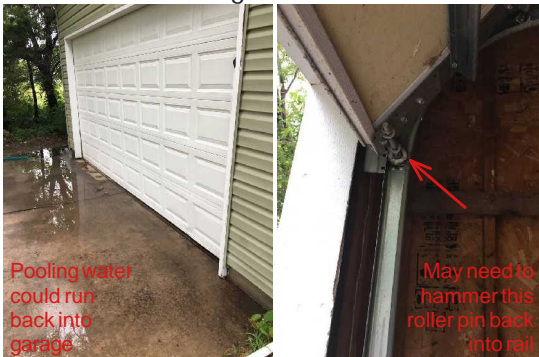
8. ☒ ☐ ☐ ☐ ☐ Doors: Metal Garage door

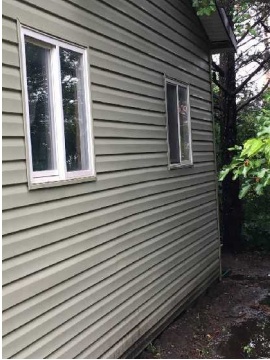
9. ☒ ☐ ☐ ☐ ☐ Windows: Aluminum slider

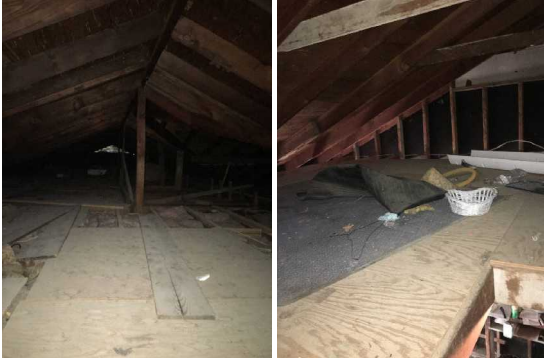
1. Method of Inspection: In the attic

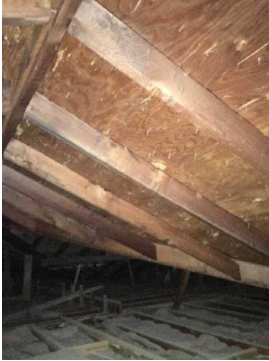
2. ☒ ☐ ☐ ☐ ☐ Roof Framing: 2x6 Rafter

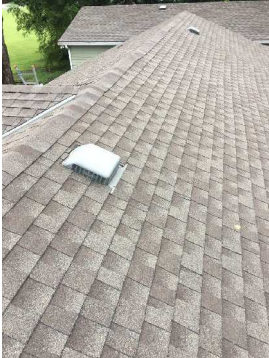
4. ☒ ☐ ☐ ☐ ☐ Ventilation: Gable, roof and soffit vents

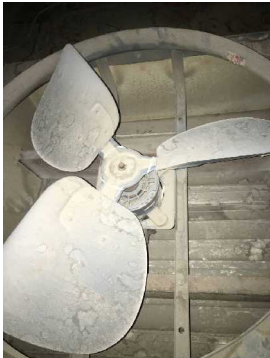
8. ☒ ☐ ☐ ☐ ☐ Attic Fan: Direct drive

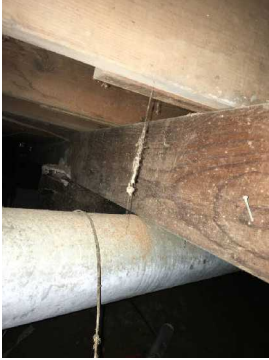
1. ☒ ☐ ☐ ☐ ☐ Structure Type: Wood frame
2. ☒ ☐ ☐ ☐ ☐ Foundation: Poured
3. ☐ ☒ ☐ ☐ ☐ Differential Movement:
4. ☒ ☐ ☐ ☐ ☐ Beams: Bonded wood

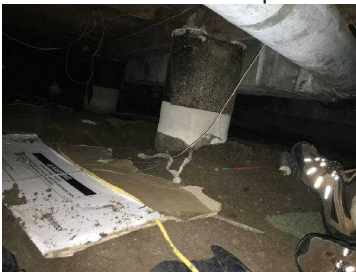
5. ☐ ☐ ☒ ☐ ☐ Bearing Walls:
6. ☒ ☐ ☐ ☐ ☐ Joists/Trusses: 2x8
7. ☒ ☐ ☐ ☐ ☐ Piers/Posts: Poured piers and steel posts

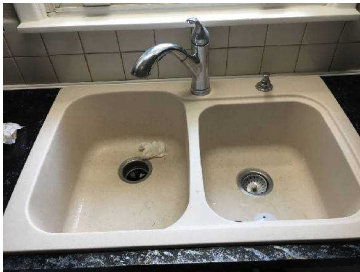
9. ☒ ☐ ☐ ☐ ☐ Sink: Corian

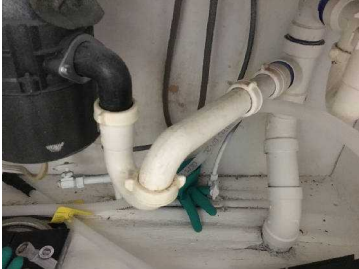
11. ☒ ☐ ☐ ☐ ☐ Plumbing/Fixtures: PVC

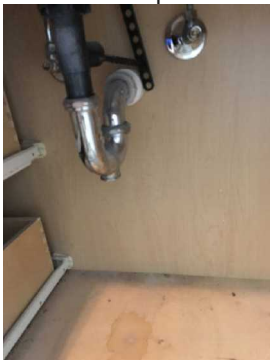
1. ☒ ☐ ☐ ☐ ☐ Closet: Walk In
2. ☒ ☐ ☐ ☐ ☐ Ceiling: Texture paint
3. ☒ ☐ ☐ ☐ ☐ Walls: Paint and tile
4. ☒ ☐ ☐ ☐ ☐ Floor: Hardwood
5. ☒ ☐ ☐ ☐ ☐ Doors: Wood
6. ☐ ☒ ☐ ☐ ☐ Windows:
7. ☒ ☐ ☐ ☐ ☐ Electrical: 110 VAC GFCI
8. ☒ ☐ ☐ ☐ ☐ Counter/Cabinet: Wood
9. ☒ ☐ ☐ ☐ ☐ Sink/Basin: One piece sink/counter top
10. ☒ ☐ ☐ ☐ ☐ Faucets/Traps: Moen fixtures with a metal trap

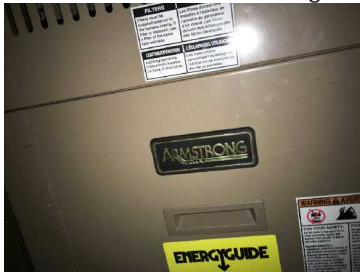
1. ☒ ☐ ☐ ☐ ☐ Heating System Operation: Adequate
2. Manufacturer: Armstrong

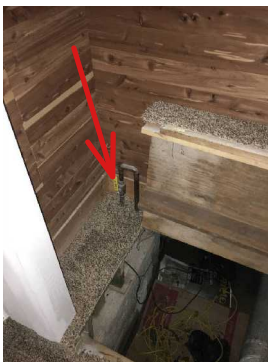
1. ☒ ☐ ☐ ☐ ☐ Main Water Shutoff: Master bedroom closet

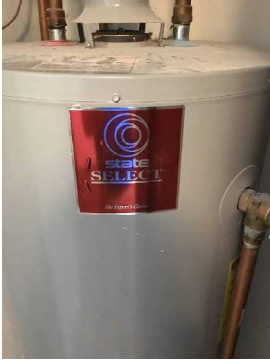
Master bathroom closet Water Heater

7. ☒ ☐ ☐ ☐ ☐ Water Heater Operation: Adequate - Unit is very close to the electrical panel.
8. Manufacturer: State

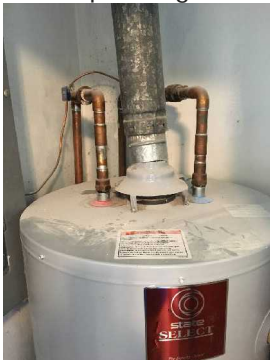
9. Model Number: GS650BRT400 Serial Number: 1643103751583
10. Type: Natural gas Capacity: 50 Gal.
11. Approximate Age: 5-10 years old Area Served: Whole house
12. ☒ ☐ ☐ ☐ ☐ Flue Pipe: Single wall

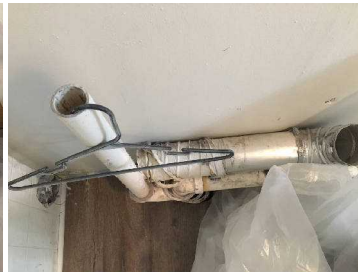
11. ☒ ☐ ☐ ☐ ☐ Washer and Dryer Electrical: 110/220
12. ☒ ☐ ☐ ☐ ☐ Dryer Vent: Plastic flex and metal

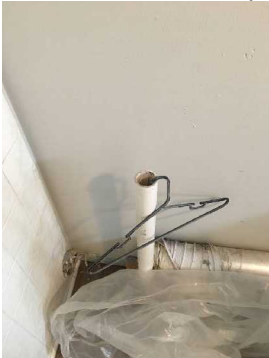
13. ☒ ☐ ☐ ☐ ☐ Washer Drain: PVC pipe

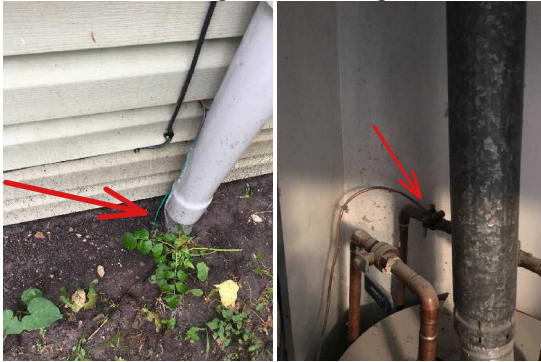
1. Service Size Amps: 200(Main Panel) Volts: 120-240 VAC
2. ☒ ☐ ☐ ☐ ☐ Service: Aluminum
3. ☒ ☐ ☐ ☐ ☐ 120 VAC Branch Circuits: Copper
4. ☒ ☐ ☐ ☐ ☐ 240 VAC Branch Circuits: Copper
5. ☒ ☐ ☐ ☐ ☐ Conductor Type: Romex
6. ☒ ☐ ☐ ☐ ☐ Ground: Plumbing and rod in ground

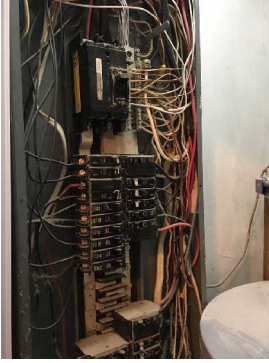
16. Maximum Capacity: 200 Amps

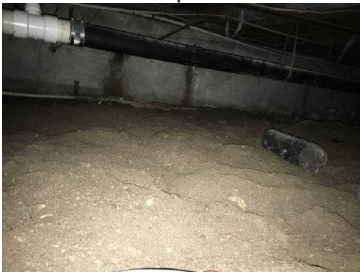
Main Crawl Space

1. Method of Inspection: In the crawl space

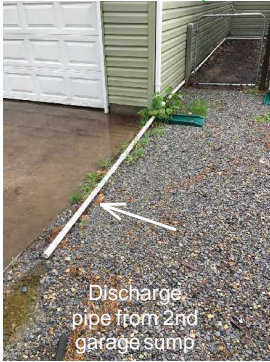
9. ☒ ☐ ☐ ☐ ☐ Sump Pump: Pedestal & submersible - There was no sump located in the the crawlspace; however, there were sumps located in both garages.
