PROPERTY CONDITION ASSESSMENT REPORT

Sample Report

St. Paul, MN

Wednesday, December 30, 2015

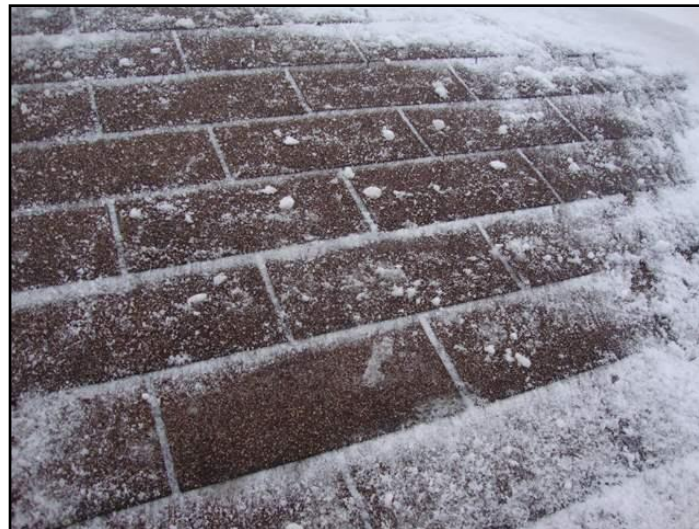
2. Granule loss

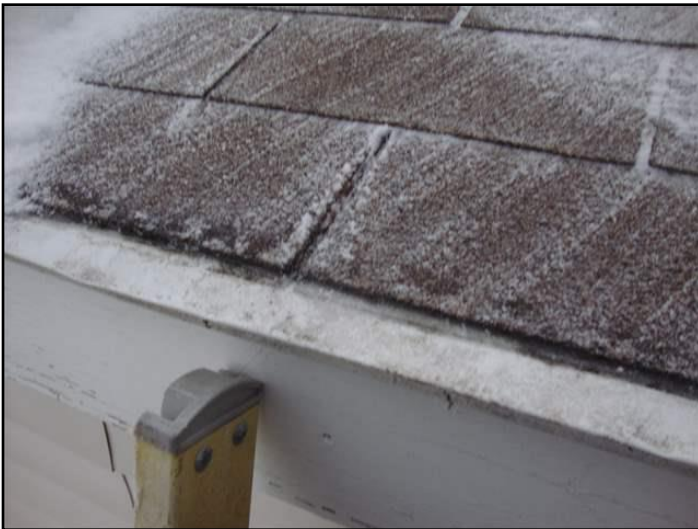
3. Overhangs too big or too small

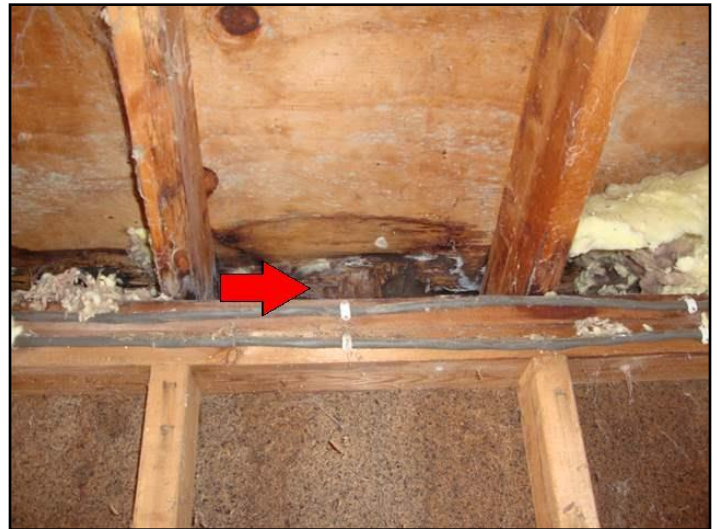
4. Overhangs too big or too small

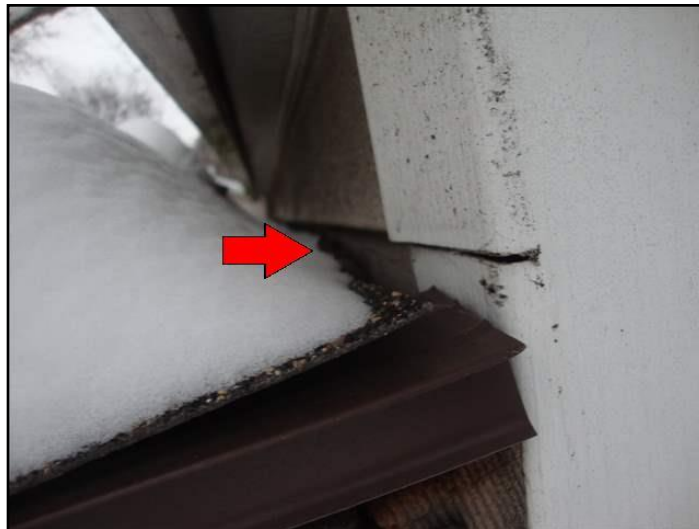
9. Missing

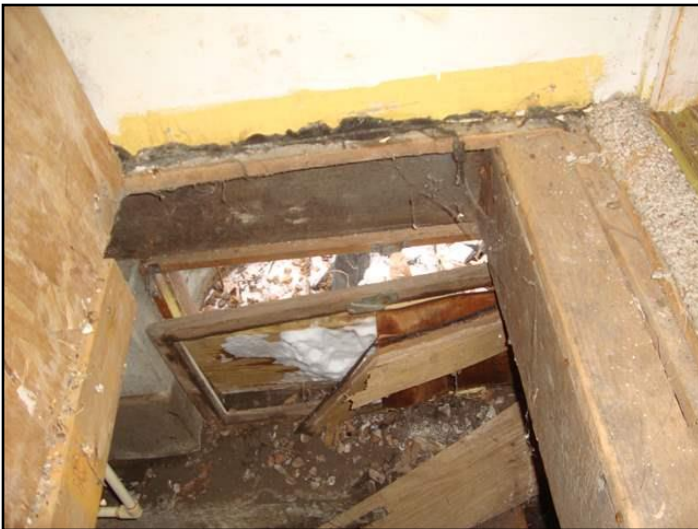
20. Broken

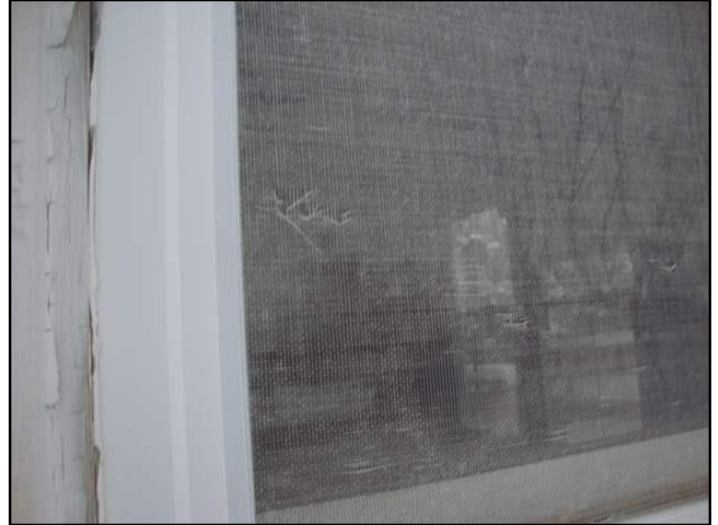
24. Torn or holes

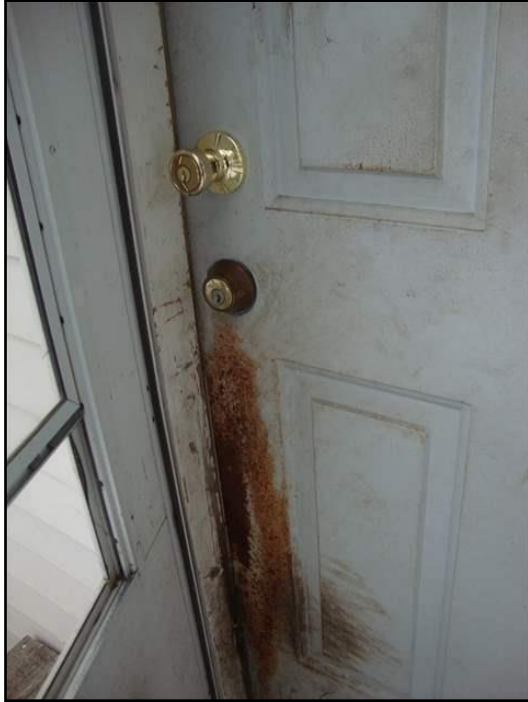
26. Rust

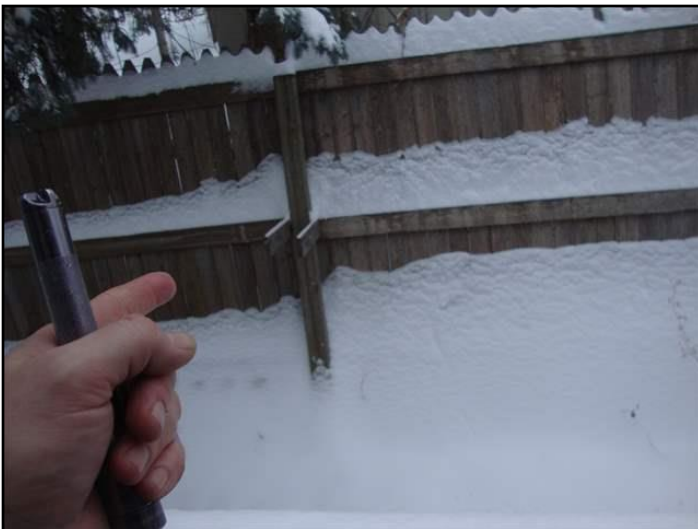
30. Damage

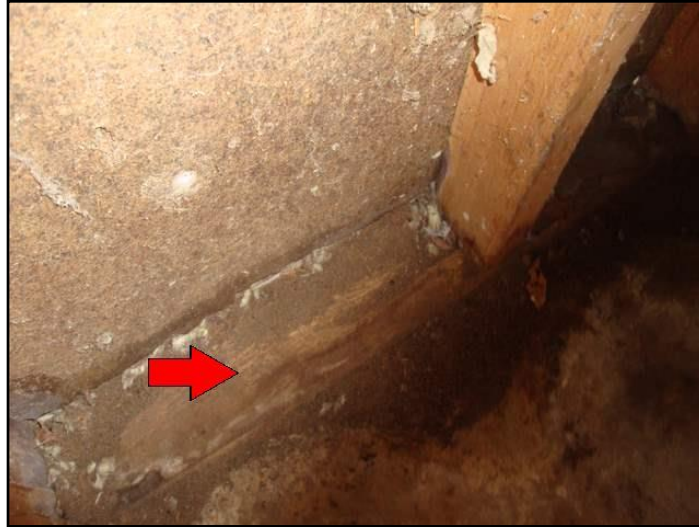
35. Rot

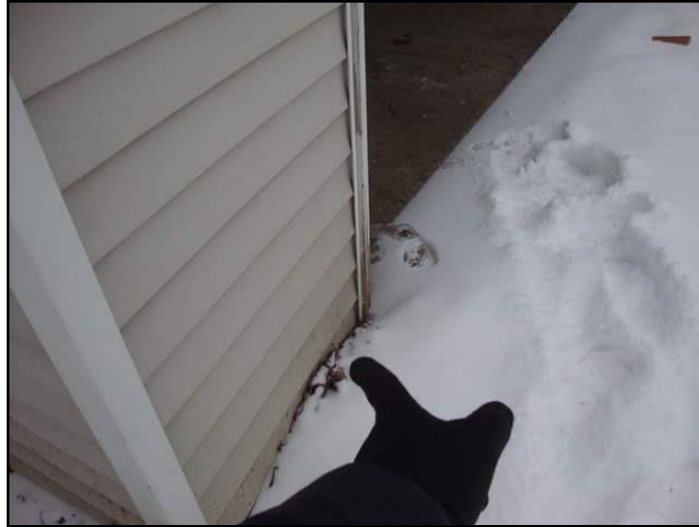
36. *Mechanical damage*

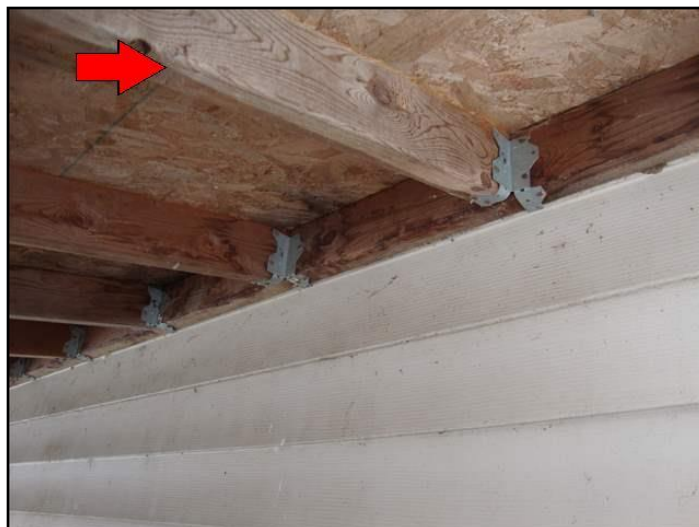
37. *Too small or overspanned*

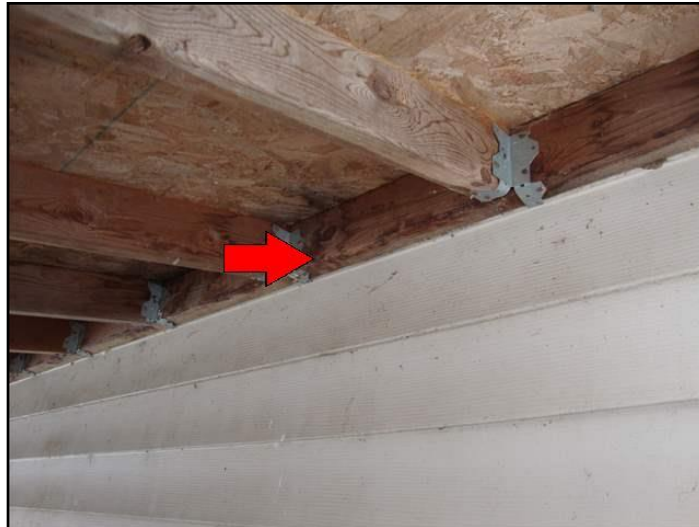
38. *Weak connections*

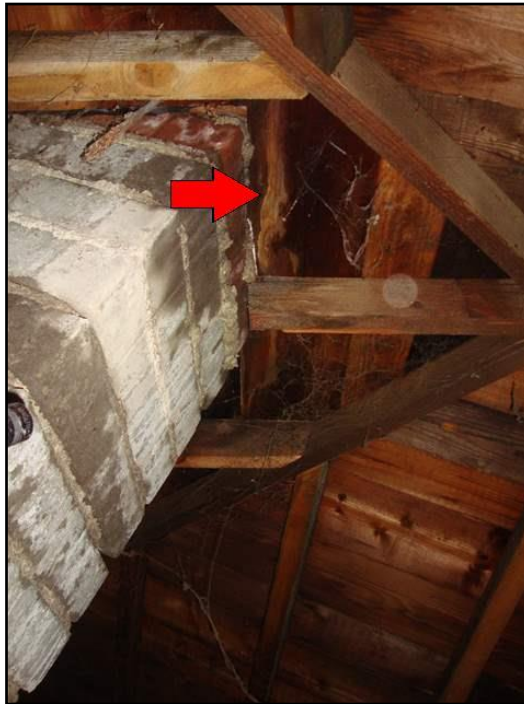
39. Water stains

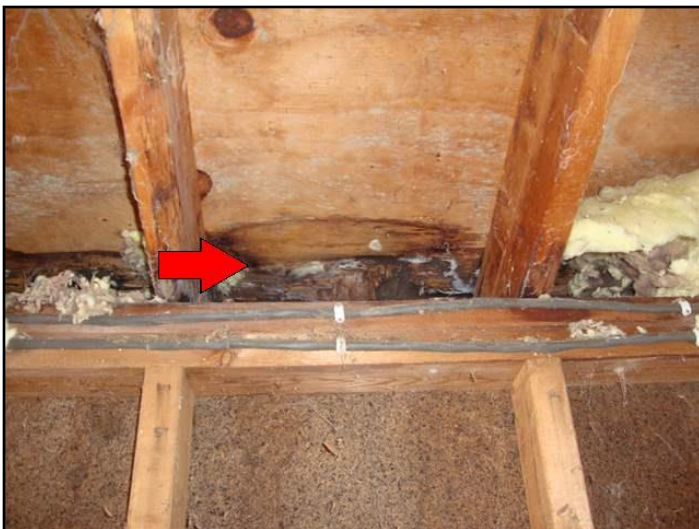
40. Rot

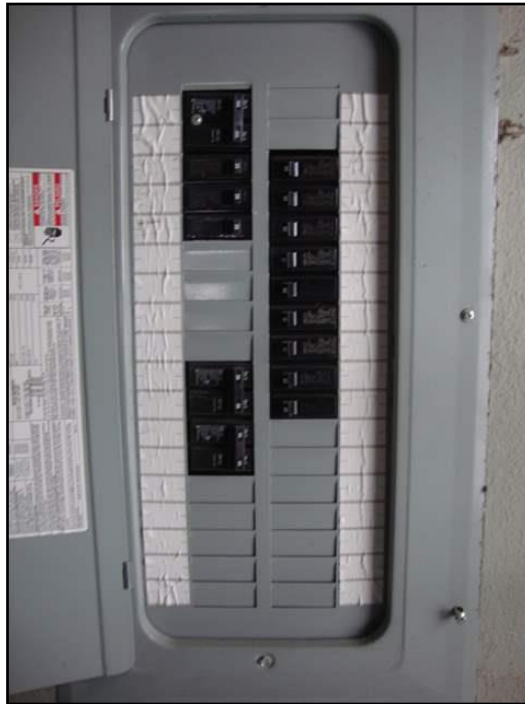
45. Circuits not labeled

44. Condition: • [Circuits not labeled](#)

Task: Improve

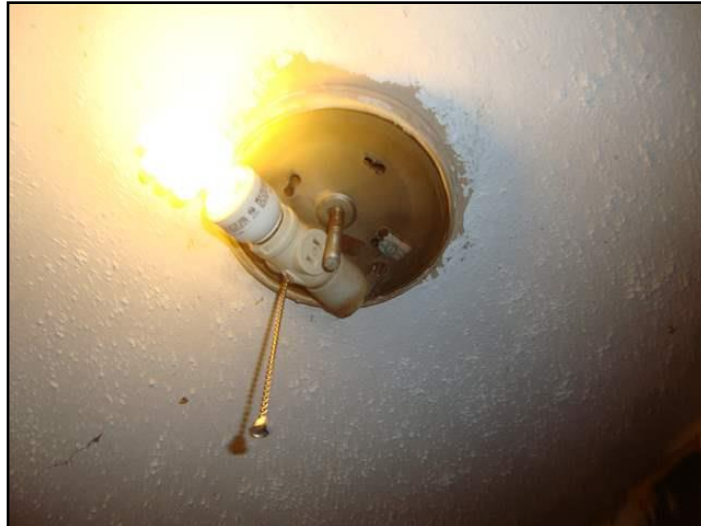
54.

52. Condition: • Missing globes

Task: Provide

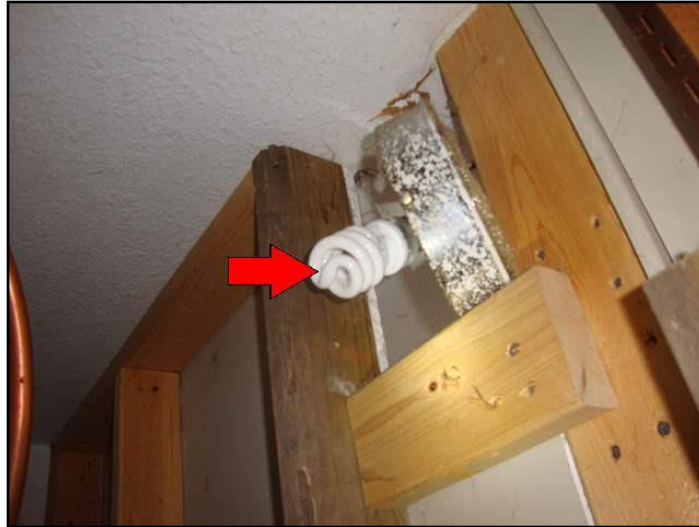
56. Loose

54. Condition: • [Loose](#)

Implication(s): Electric shock | Fire hazard

Task: Replace

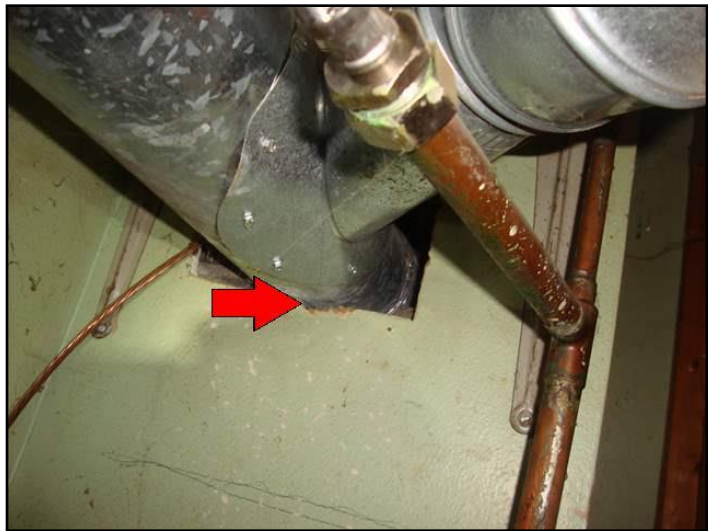
66. Combustible clearance

69. Condition: • [Combustible clearance](#)

Implication(s): Fire hazard

Task: Improve

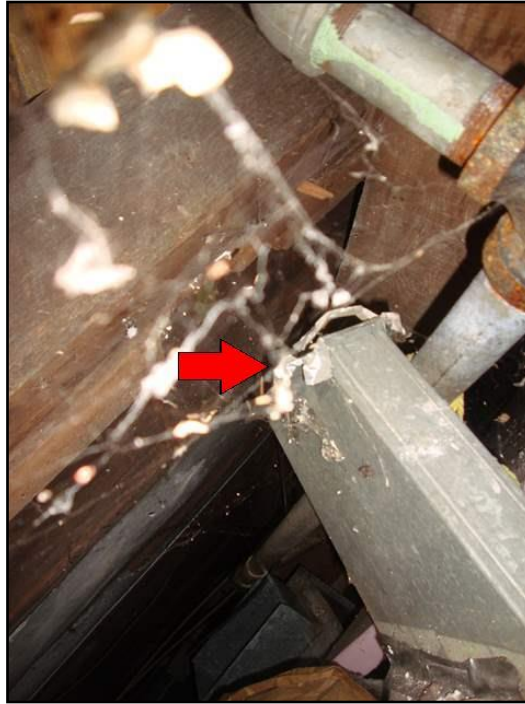
68. *Disconnected ducts*

71. Condition: • [Disconnected ducts](#)

Task: Repair

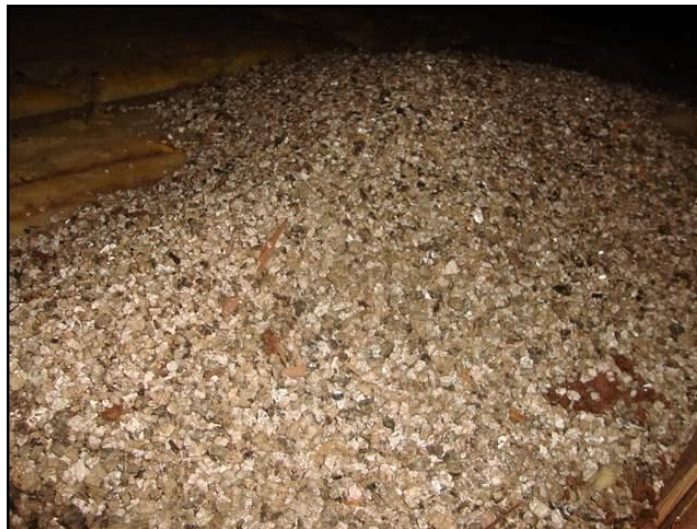
75. Possible Zonolite

80. Condition: • [Possible Zonolite](#)

Task: Further evaluation

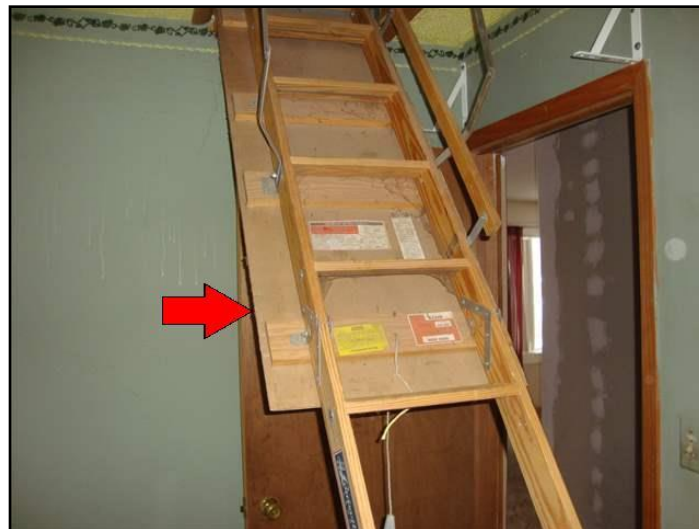
76. Not insulated

81. Condition: • [Not insulated](#)

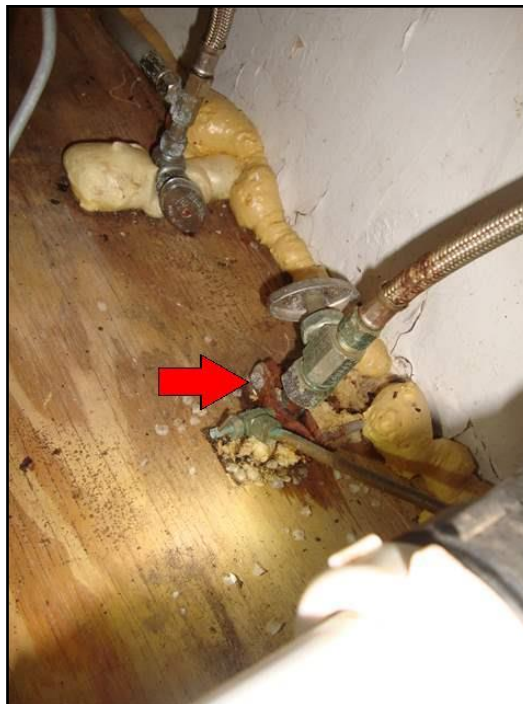
81. *Non-standard material*

91. Condition: • [Non-standard material](#)

Saddle valves are prone to leak. Replace with in line shut off valve.

Implication(s): Chance of water damage to contents, finishes and/or structure | Reduced system life expectancy | No water

Location: Kitchen

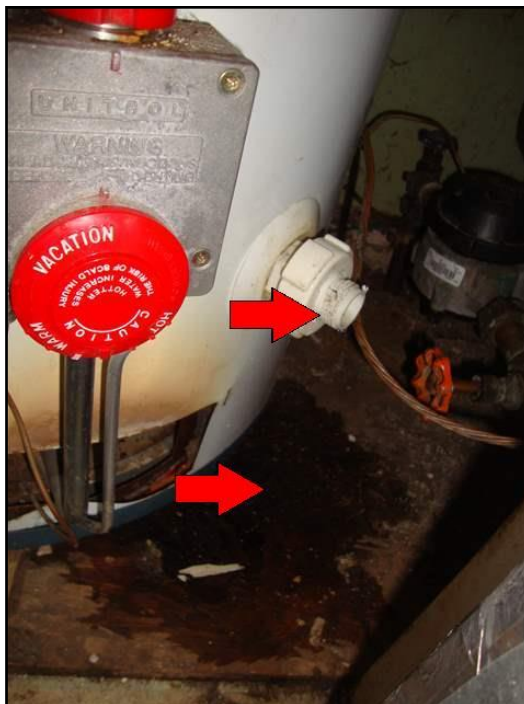
83.

WATER HEATER \ Drain valve

94. Condition: • Leak

Task: Repair

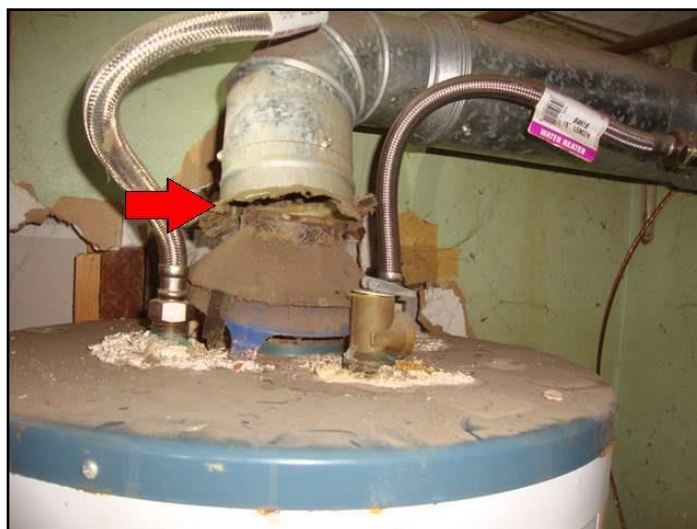
85. Poor connections

98. Condition: • [Poor connections](#)

Poor connections create a potential carbon monoxide hazard.

Implication(s): Equipment not operating properly | Hazardous combustion products entering home

Task: Repair

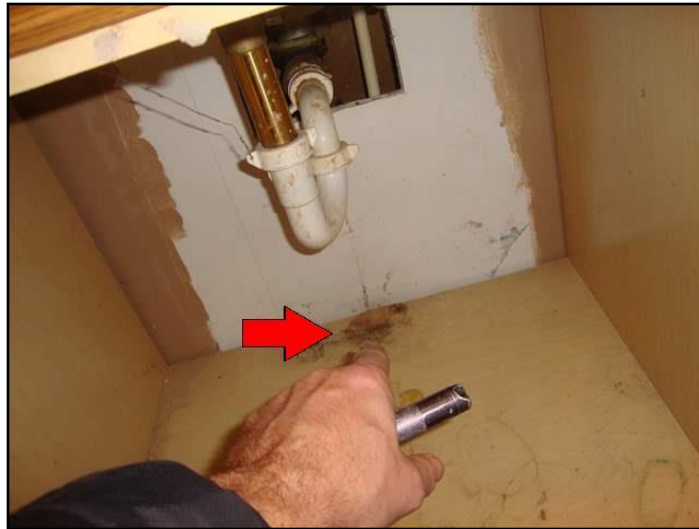
86. Leak

99. Condition: • [Leak](#)

Task: Repair

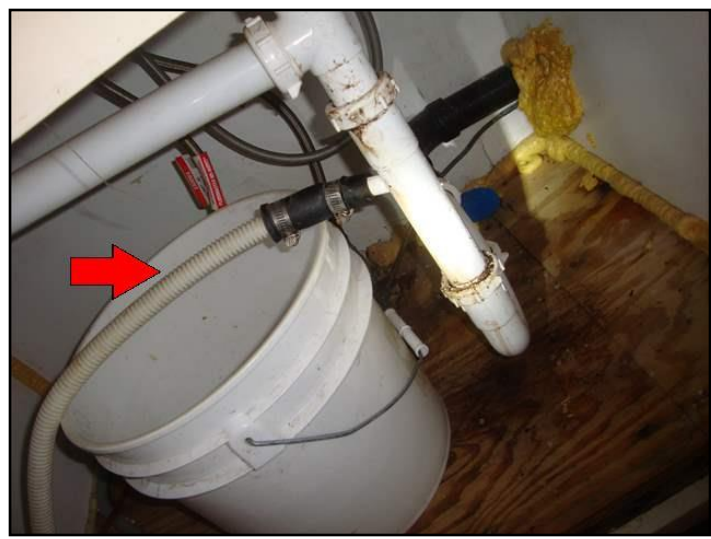
88. Dishwasher drain connections

101. Condition: • [Dishwasher drain connections](#)

Implication(s): Chance of water damage to contents, finishes and/or structure

Location: Kitchen

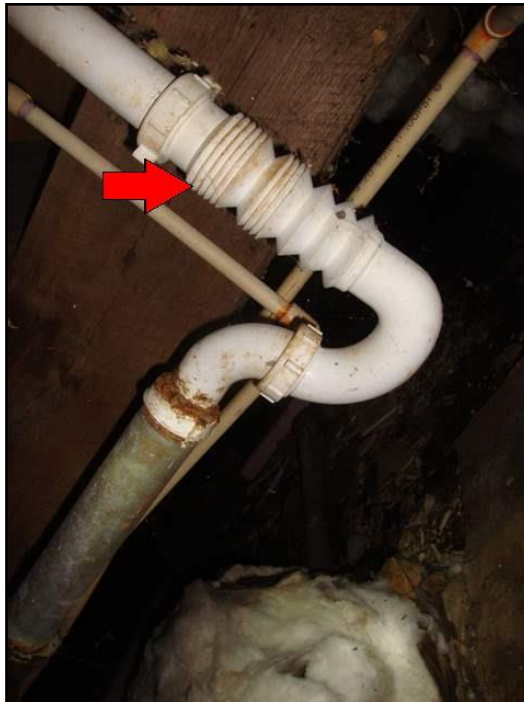
89. Nonstandard materials and patches

103. Condition: • [Nonstandard materials and patches](#)

Implication(s): Chance of water damage to contents, finishes and/or structure | Sewage entering the building

Location: Crawl Space

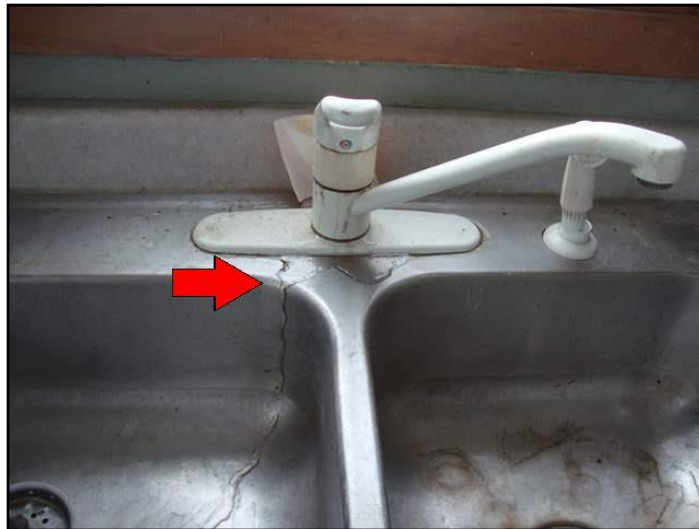
90. *Drip, leak*

106. Condition: • [Drip, leak](#)

Implication(s): Chance of water damage to contents, finishes and/or structure

Task: Repair

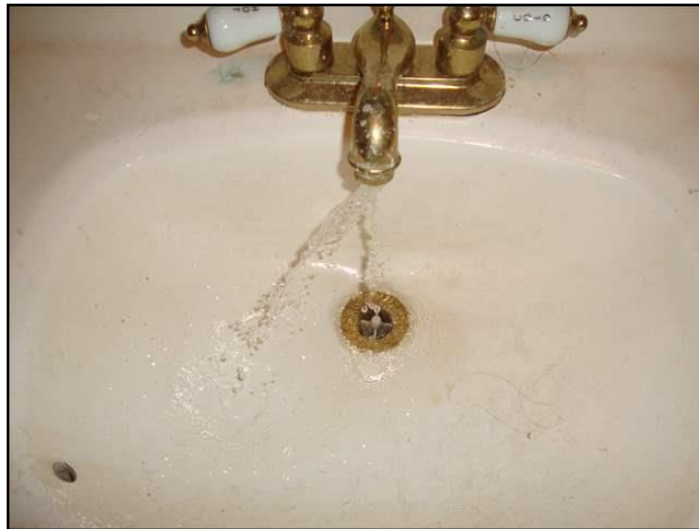
91. *Obstructed aerator*

107. Condition: • [Obstructed aerator](#)

Task: Repair

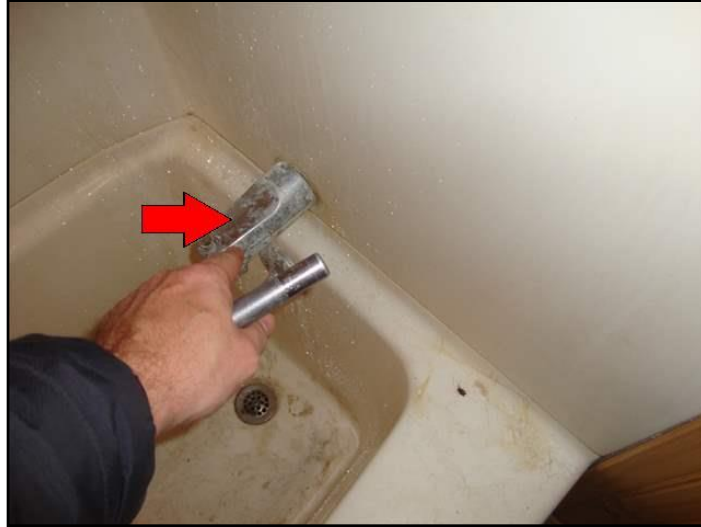
92. Loose

108. Condition: • [Loose](#)

Implication(s): Equipment failure

Task: Repair
Time: Less than 1 year

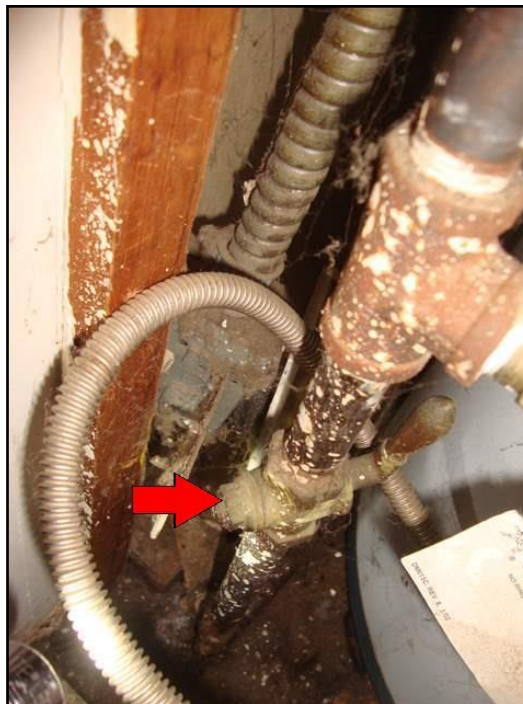
95. *Inappropriate materials*

113. Condition: • [Inappropriate materials](#)

Old, unapproved "lube" or "plug" gas valves and unions should be monitored for leaks and replaced when appliances are replaced or upgraded or as required by local code.

Location: Utility Room

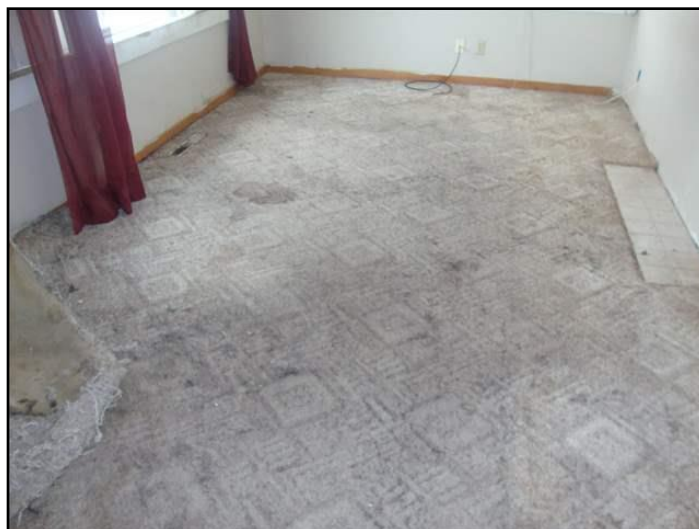
97.

117. Condition: • Excessive stains and wear

Task: Replace

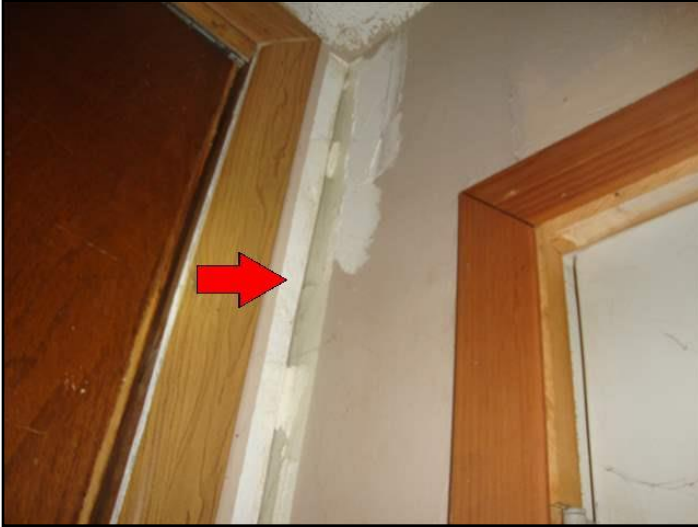
98.

118. Condition: • Unfinished areas.

Task: Repair

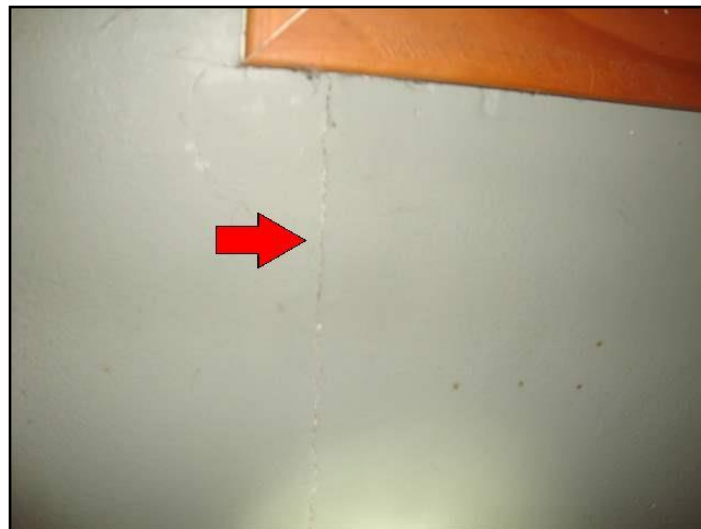
100. Typical flaws

119. Condition: • Typical flaws

Implication(s): Cosmetic defects

Location: Various

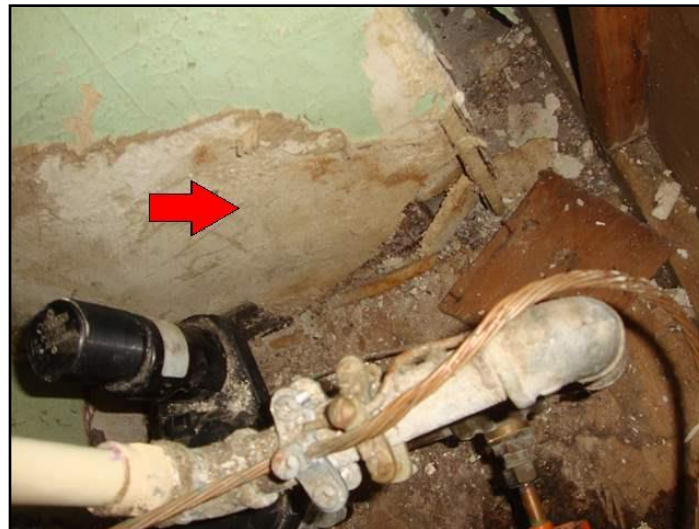
101. Water damage

120. Condition: • [Water damage](#)

Implication(s): Cosmetic defects

Task: Repair

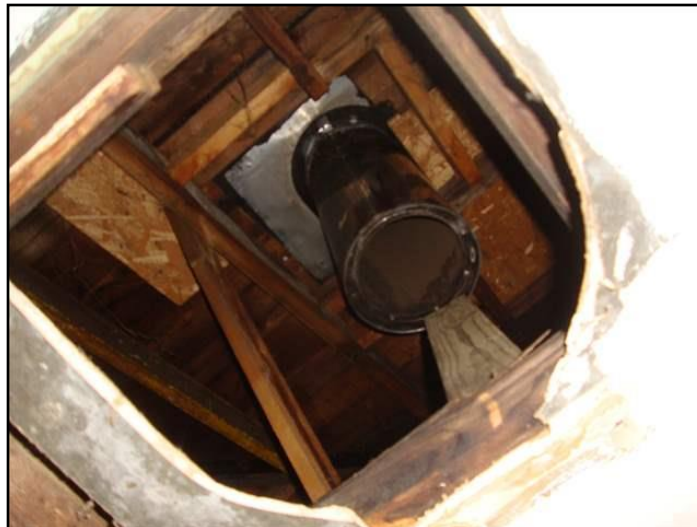
102. *Missing sections*

122. Condition: • [Missing sections](#)

Missing ceiling sections are creating excessive heat loss and ice dams.

Implication(s): Cosmetic defects | Damage or physical injury due to falling materials

Task: Repair

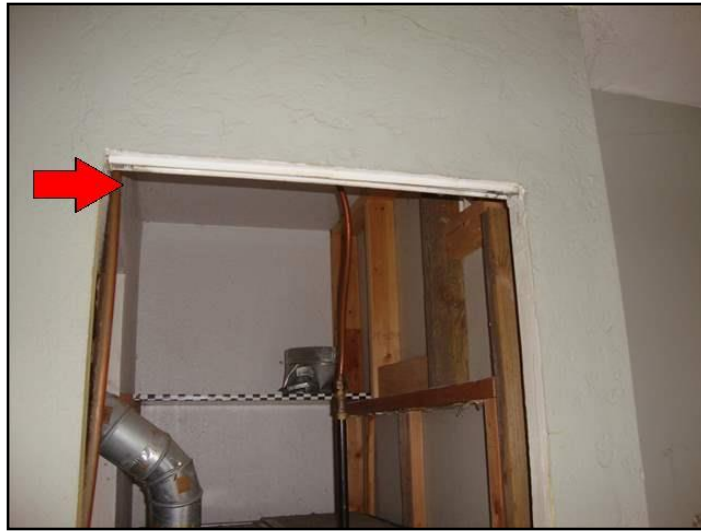
103.

124. Condition: • Missing

Task: Provide

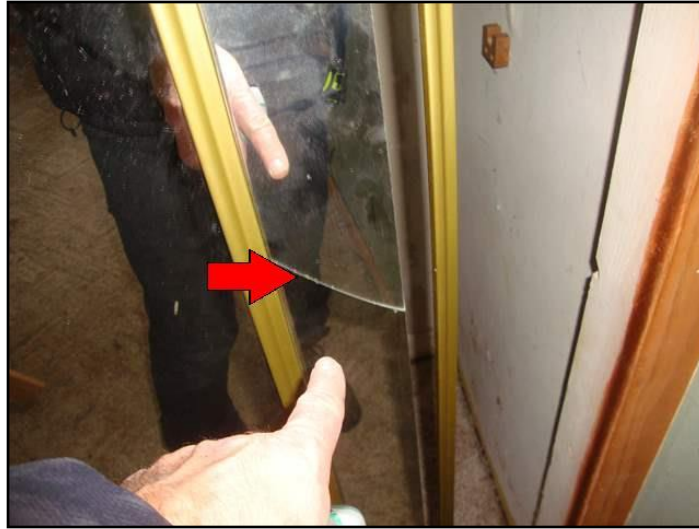
105. Inoperable

126. Condition: • [Inoperable](#)

Cracked glass and broken frame.

Task: Replace

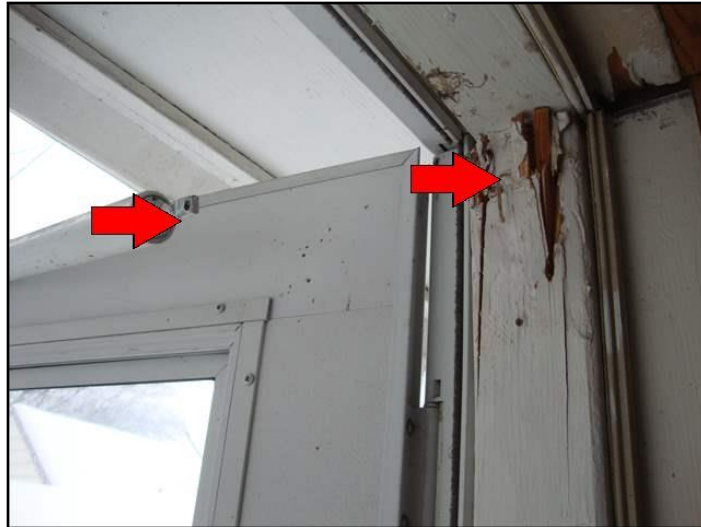
106. Inoperable

128. Condition: • [Inoperable](#)

Task: Repair

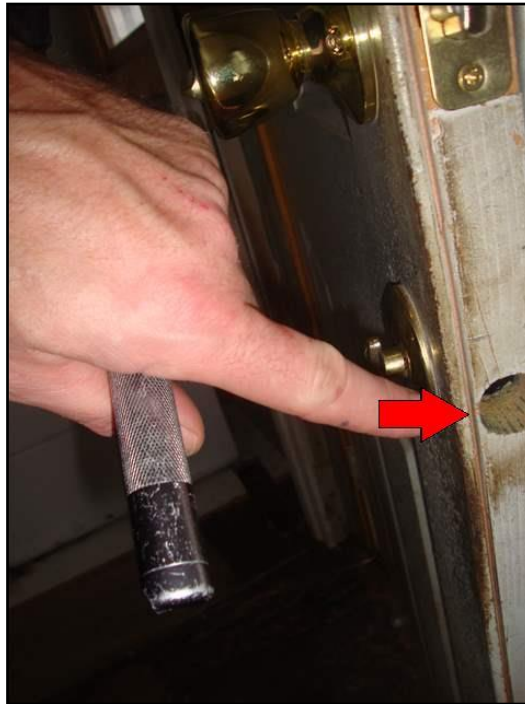
107. Broken

129. Condition: • [Broken](#)

Missing bolts.

Implication(s): Cosmetic defects | System inoperative or difficult to operate

Task: Repair

Time: Immediate

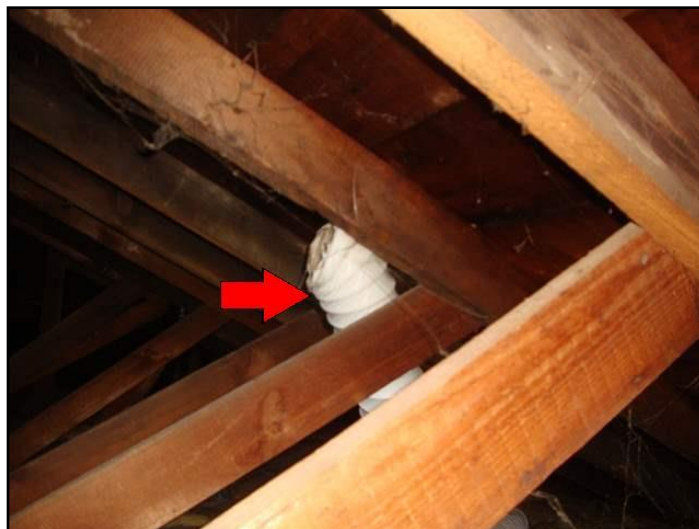
110. *Not vented to exterior*

137. Condition: • [Not vented to exterior](#)

Implication(s): Chance of condensation damage to finishes and/or structure

Task: Repair

Time: Immediate

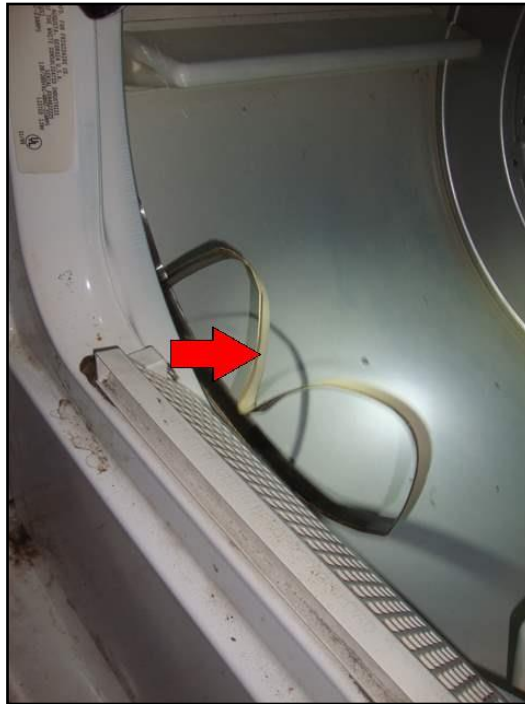
111. *Inoperative*

141. Condition: • Inoperative

Damaged drum or bearing.

Task: Repair or replace

Time: Less than 1 year
