Home Inspection Report

123 Main Street, Pensacola, AL 32506

Tuesday, May 14, 2019

2800

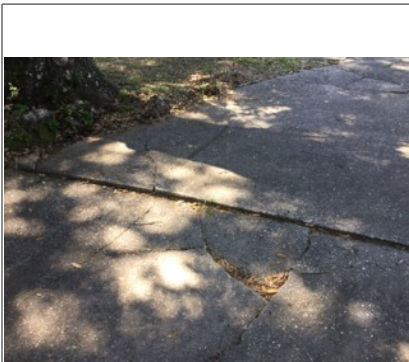
DRIVEWAY
Driveway has large settling cracks and upheaval from tree roots. Recommend repair as needed

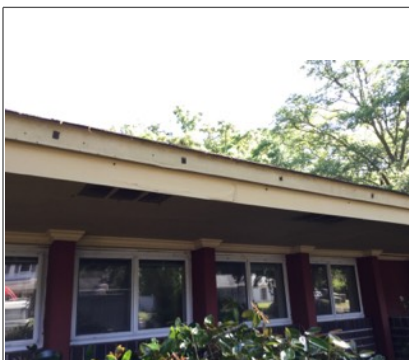
5. Fascia on North West corner is rotted. Recommend repair

Fascia has wood rot on North West corner of roof

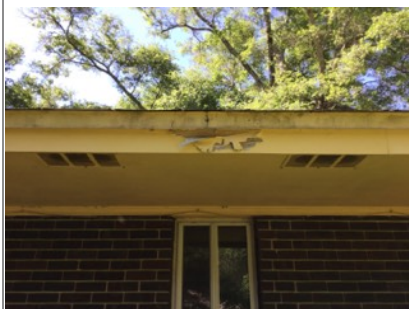
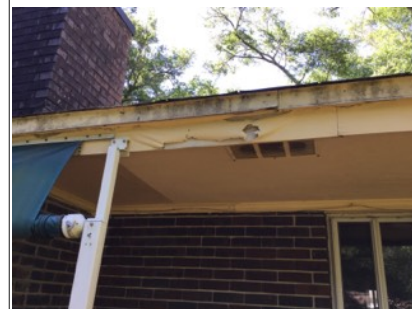
Wood rot on Fascia

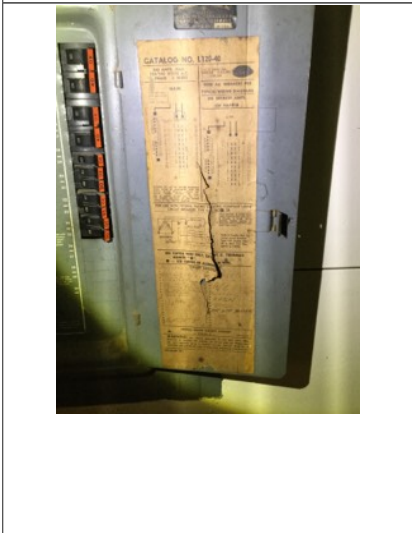
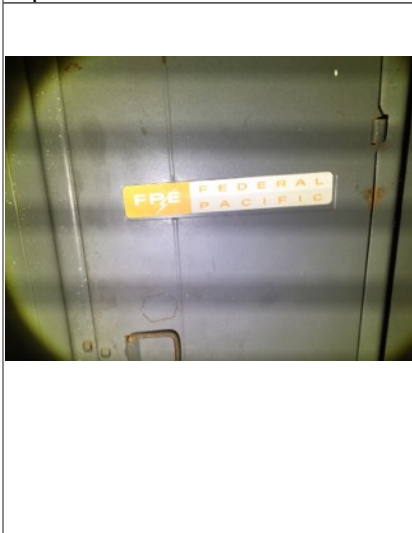
MAIN ELECTRICAL PANEL
 Wiring in main electrical panel is solid Branch wiring. Recommend repair. SAFETY HAZARD
