Home Inspection Report

46578 Anywhere St., Hagerstown, MD 21740

Saturday January 28, 2017

Stine's Home Inspection Services LLC
12907 Draper Road
Clear Spring , MD 21722
(301) 667-8927
gstine5402@gmail.com

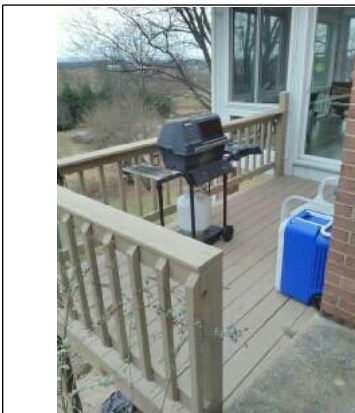
Comments Deck is in good condition and had been properly constructed.

General deck veiw

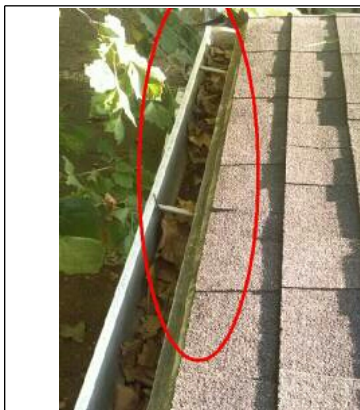
Comments Insides of gutters are full of debris recommend cleaning

Gutters need cleaning

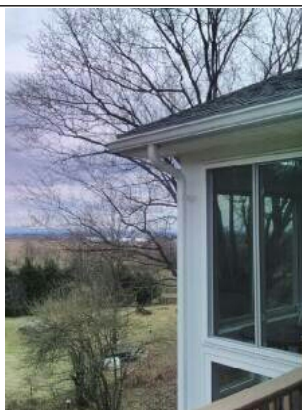
Gutters and downspouts in good condition

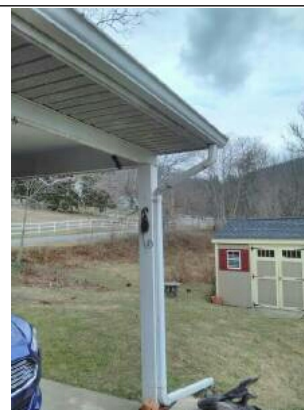
Gutters and downspouts in good condition with proper terminations

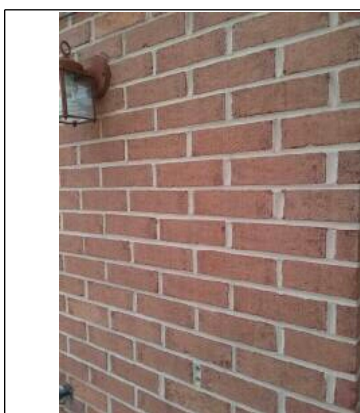
Comments brick veneer in overall good condition

Brick veneer

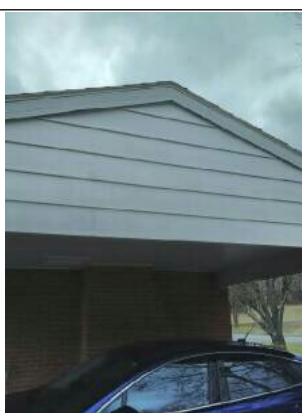
Aluminum siding on North gable

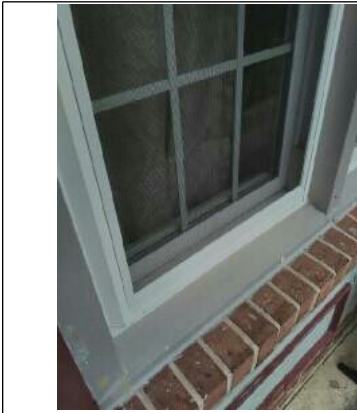
Wrapped window trim

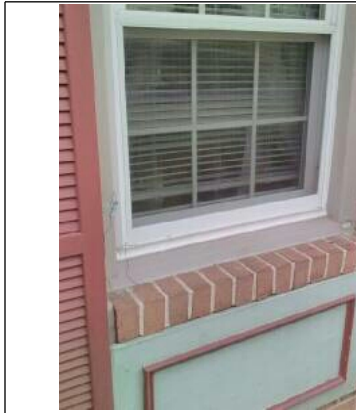
Wrapped window trim

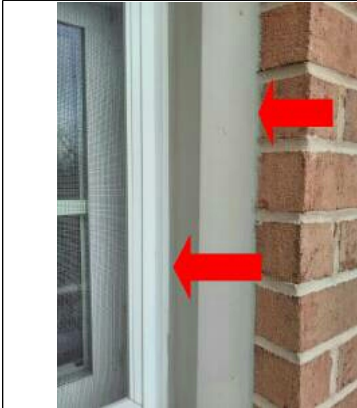
Comments caulking in good condition

Good window caulking

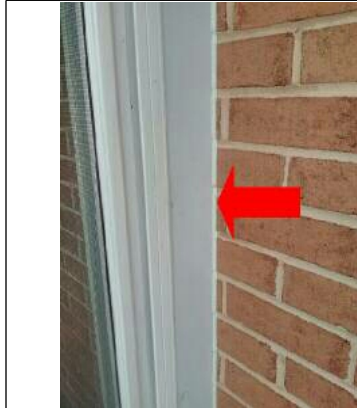
Good caulking

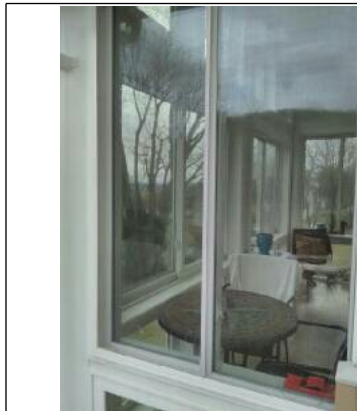
Sunroom window

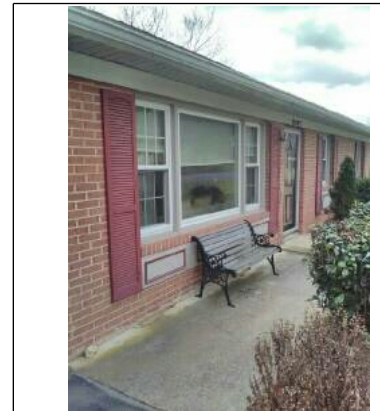
Comments newer good quality replacement windows have been installed.

Newer replacement windows

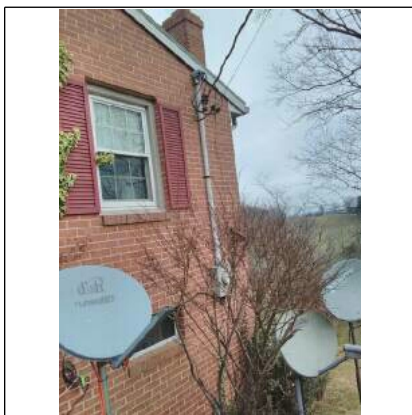
Overhead electric service entrance

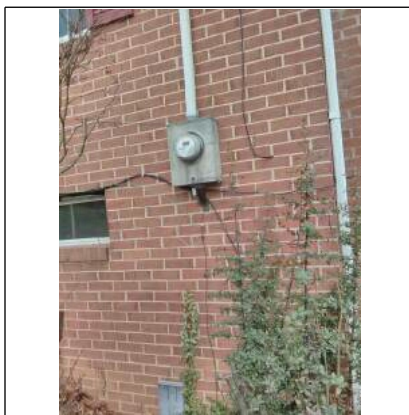
Electric meter/meter box

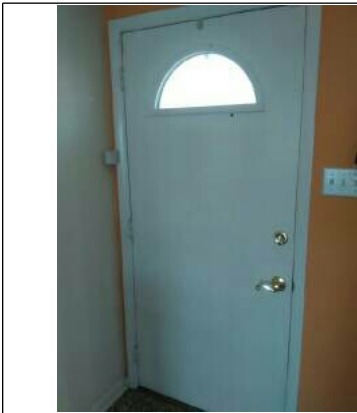
Front door

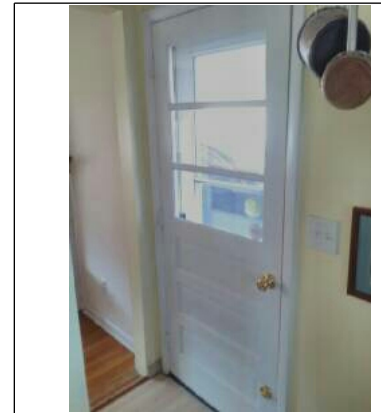
Carport door

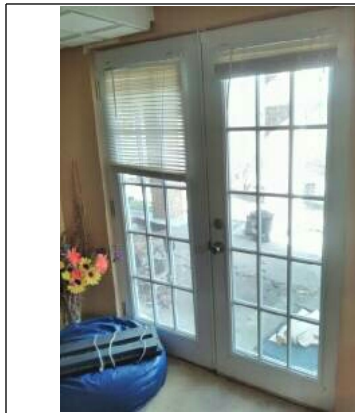
Basement walk out door

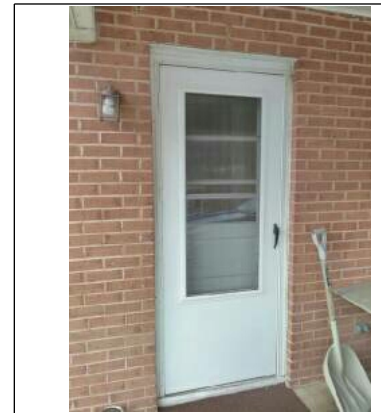
Carport exterior door

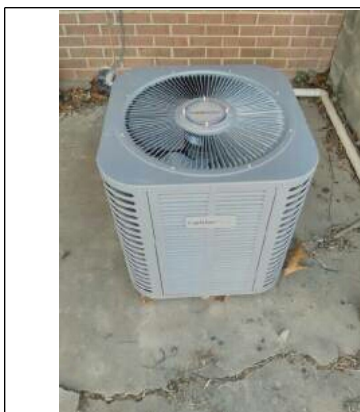
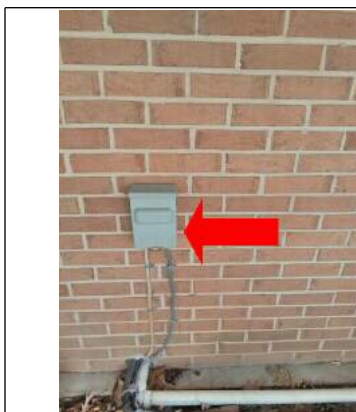
Condenser disconnect

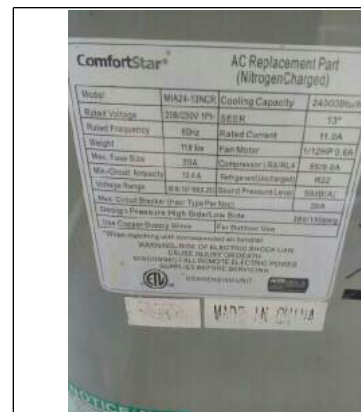
Comments AC in good condition at the time of the inspection

Condenser/AC information

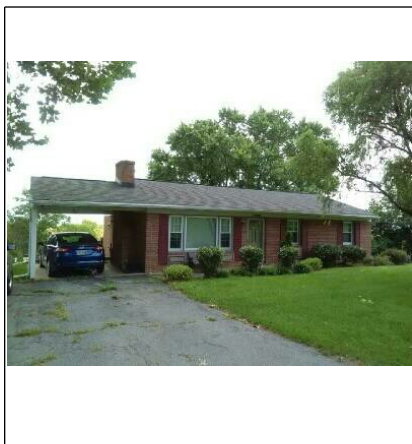
General carport veiw

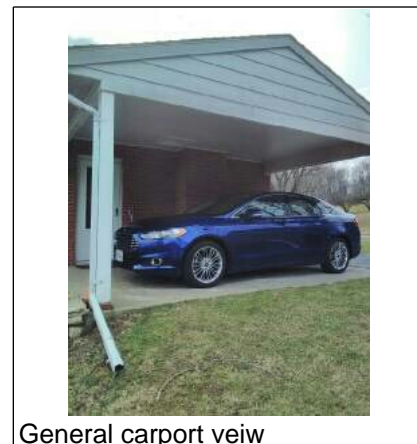
General carport veiw

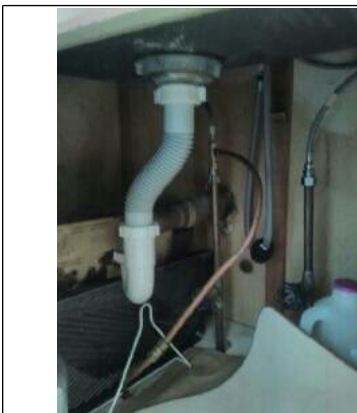
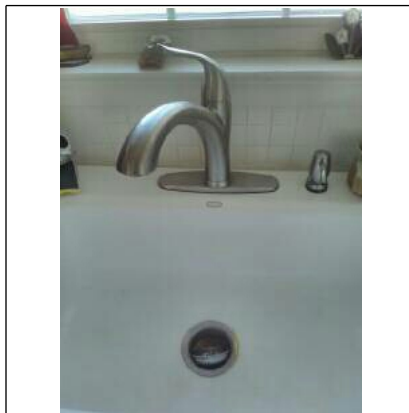
Comments Water flow was normal with several fixtures operated at the same time. There were no visible active piping leaks at the time of the inspection. Some minor corrosion around the joints, but no visible leaks at this time.

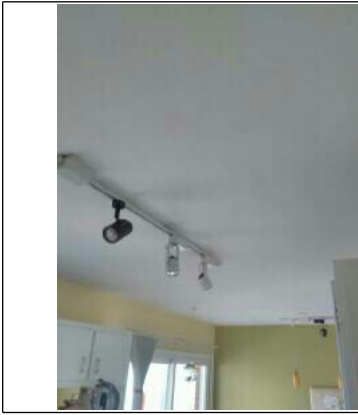
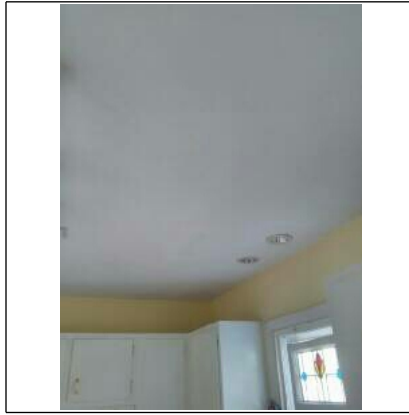
Kitchen

Comments Typical settling cracks

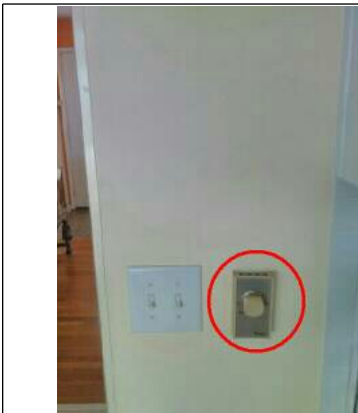
Kitchen t-stat

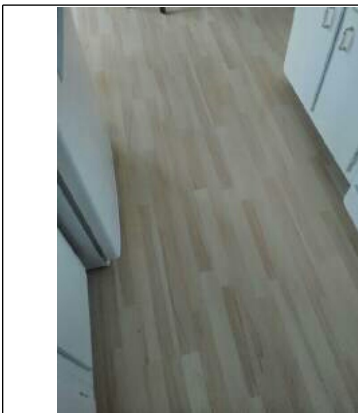
Comments flooring is in good condition.

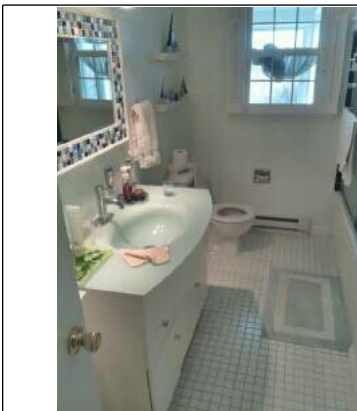
General Bathroom view

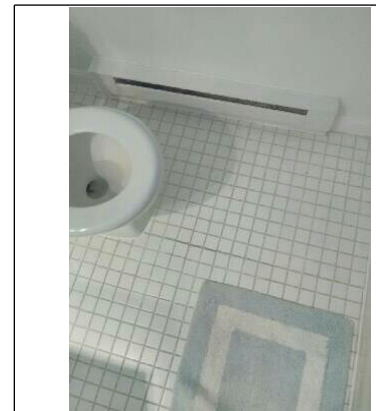
Heat source (baseboard)

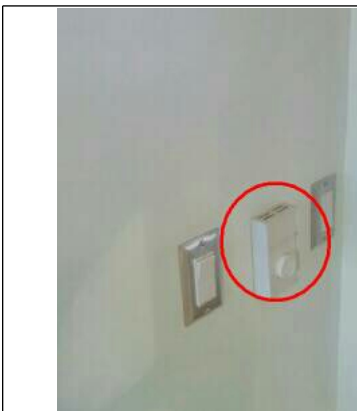
T-stat bathroom heat

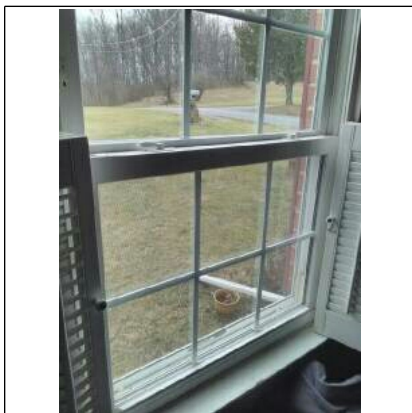
Comments New replacement windows have been recently installed

Newer replacement windows

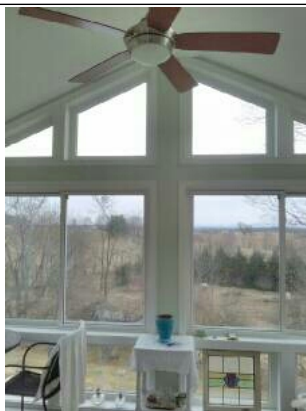
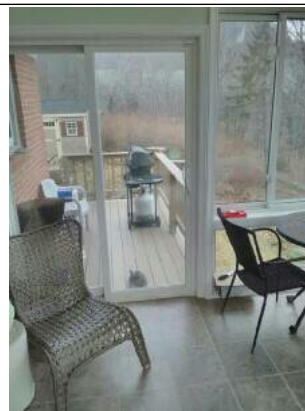
Comments Sunroom appears to have been recently added.

Sunroom general veiw

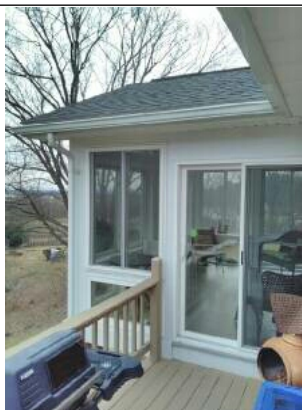
Sunroom exterior general veiw

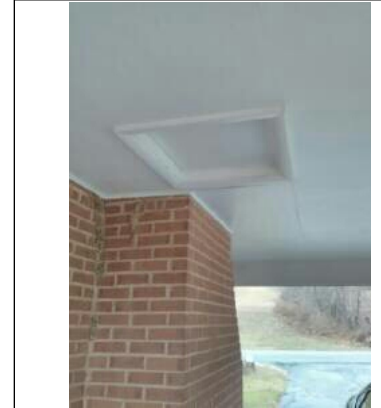
Attic access door on carport

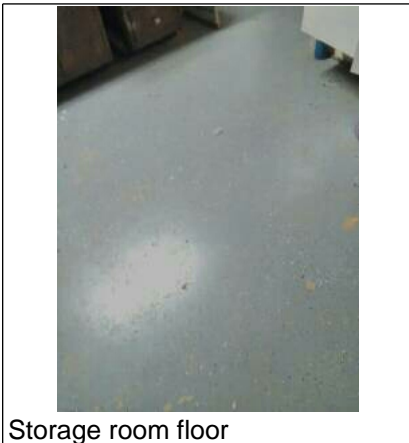
Material ☒ Concrete
Condition ☒ Satisfactory ☒ Typical cracks

Storage room floor

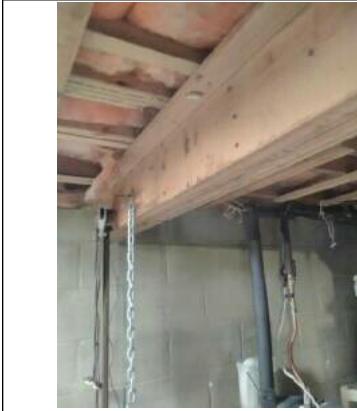
Condition ☒ Satisfactory
Material ☒ Wood
Comments Only about a third of the beams were inspected due to interior finishes.

Beam

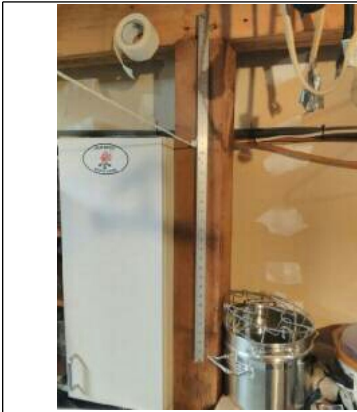
Column supporting beam

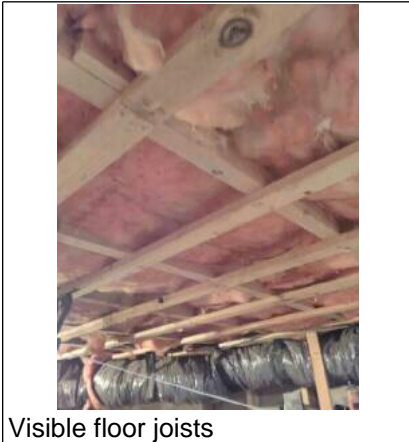
Basement

Visible floor joists

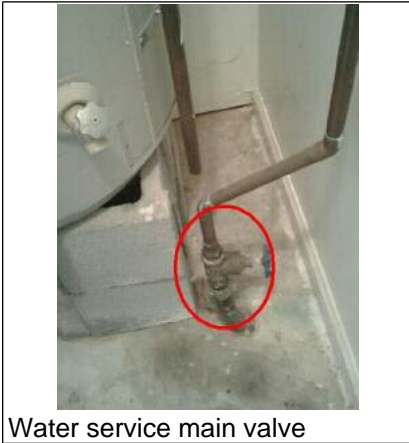
Water service main valve

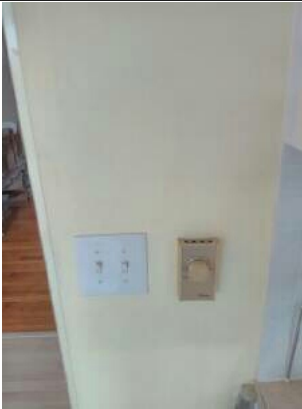
Thermostats in each room for baseboard heat

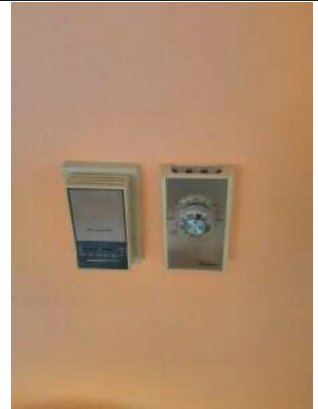
AC thermostat left heat thermostat right

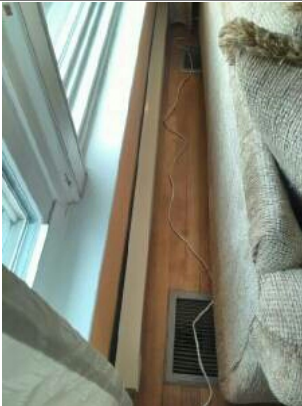
Baseboard heater living room/ AC vents

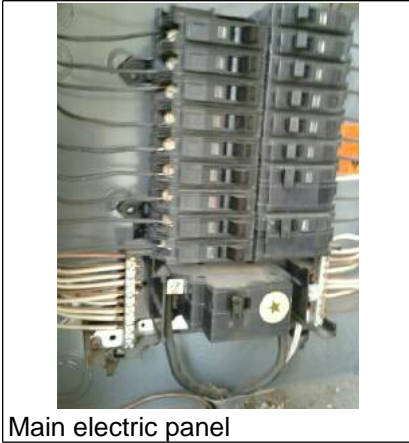
Main electric panel

Condition ☒ Satisfactory
Adequate Clearance to Panel ☒ Yes
Amperage/Voltage ☒ 100a
Breakers/Fuses ☒ Breakers
Appears grounded ☒ Yes
GFCI breaker ☒ No
AFCI breaker ☒ No
Main wire ☒ Aluminum Condition: ☒ Satisfactory
Branch wire ☒ Copper
Branch wire condition ☒ Satisfactory
Comments Panel size appeared to be compatible to service size.
Photos

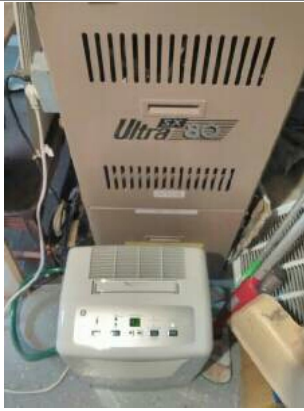
AC fan/coil unit.

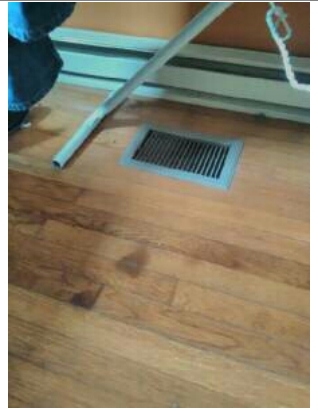
AC vent
