For the Property at:
1SOMEPLACE
SOMEWHERE, NS

Prepared for: CAHPI ATLANTIC
Inspection Date: Friday, January 22, 2010
Prepared by: Armand Dufresne

Total Check Home Inspection
216 New Harbour Road, Suite RR1 Hubbards
Blandford, NS B0J1T0
1 866 704 4888
Fax: 1 866 704 4888

Report No. 1116, v.0

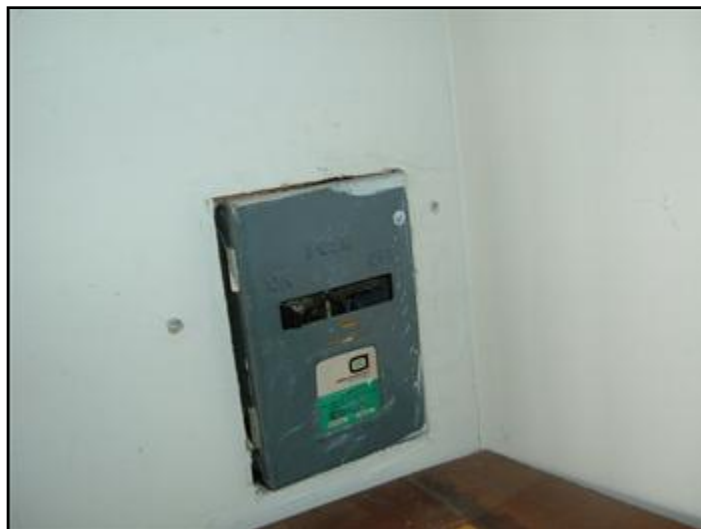
19.

Condition: • Abandoned wire

Large wire next to panel. Purpose unknown.

Location: First Floor**Task:** Remove**Time:** Immediate**DISTRIBUTION SYSTEM \ Switches****Condition:** • There is a switch box in closet purpose unknown. Also could not open to inspect.**Implication(s):** Poor location. Not easy to locate in an emergency. Safety/fire hazard**Location:** Bedroom**Task:** Further evaluation**Time:** Immediate

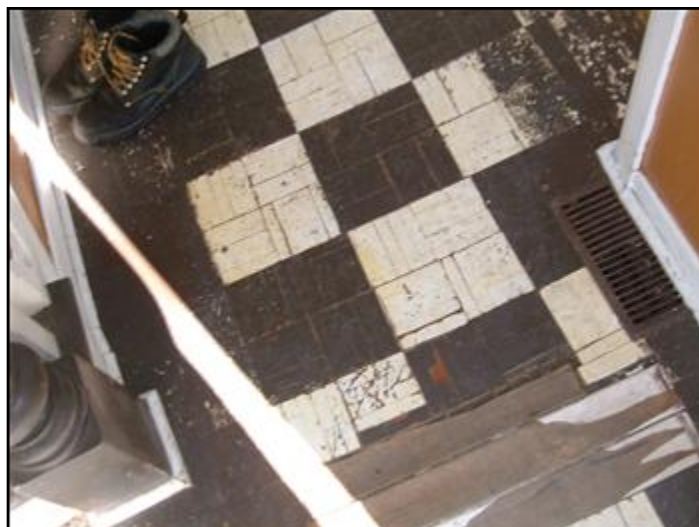
29.

Condition: • Loose or missing pieces

Task: Repair or replace

Time: Discretionary

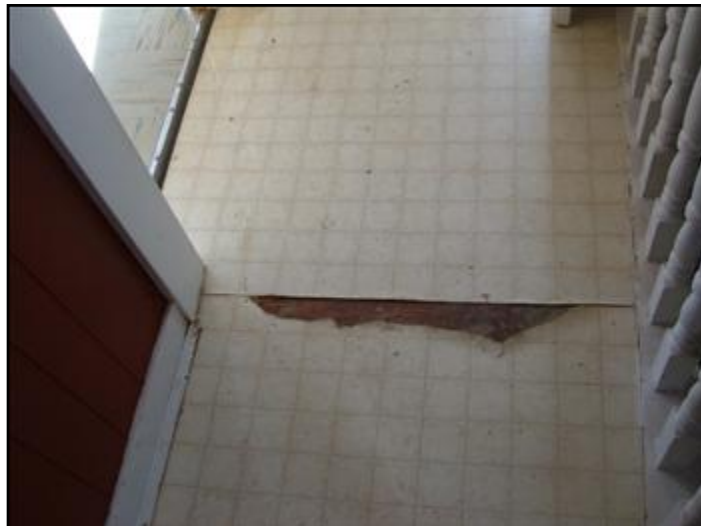
30.

Condition: • Damage

Task: Replace

Time: Discretionary
