Insight Home Inspections

Home Inspection Report

850 E 95th St

Inspected on Fri, Nov 2 2018 at 9:04 AM

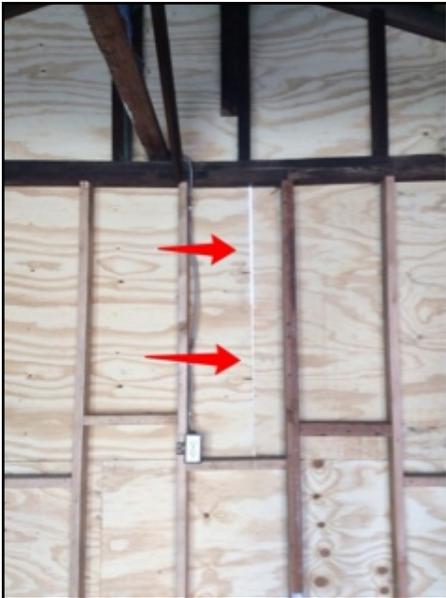
Figure 9-1

Multiple gaps along back wall of garage. Water proof material is not present behind wood siding. This may create breakdown of material over time.

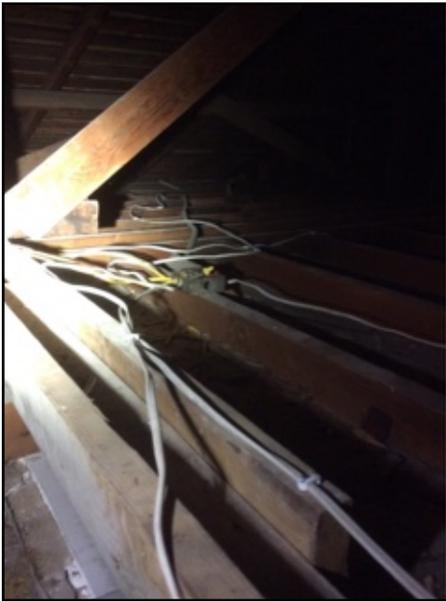
Figure 14-1

Comment 14:
Covers are needed on all junction boxes.

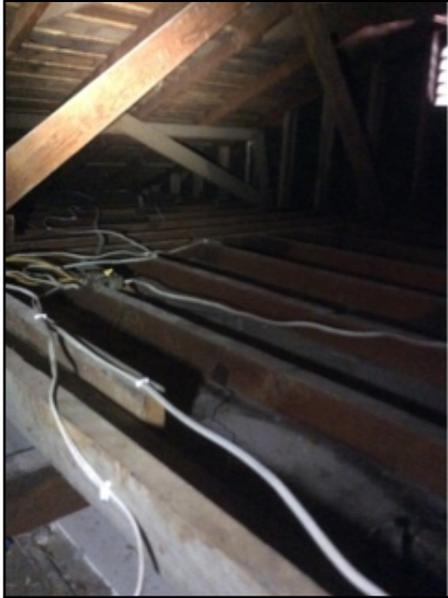
Figure 24-1

Comment 24:
Insulation needs to be installed in attic.

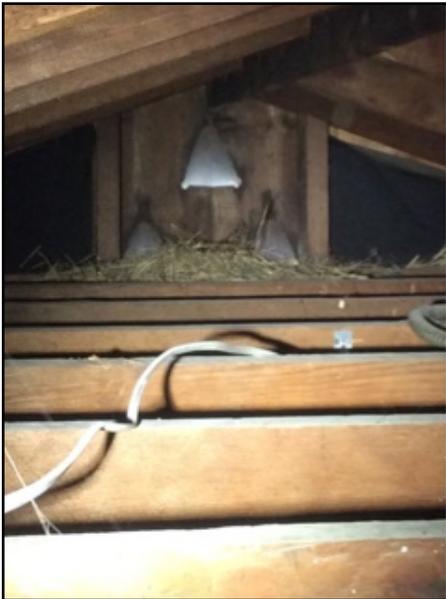
Figure 25-1

Comment 25:
Birds nest are present in attic due to lack of screening from gable end vents.

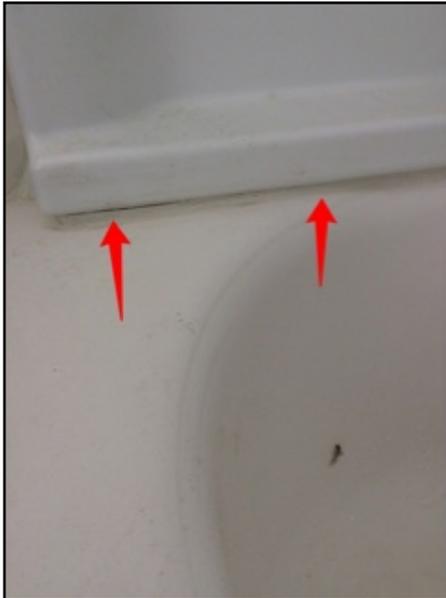
Figure 28-1

Comment 28:
Water seal is needed around tub edge.

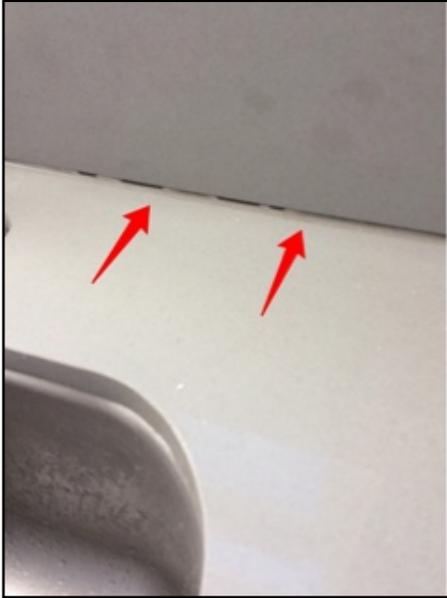
Figure 31-1

Water seal is needed behind sink to prevent water intrusion.

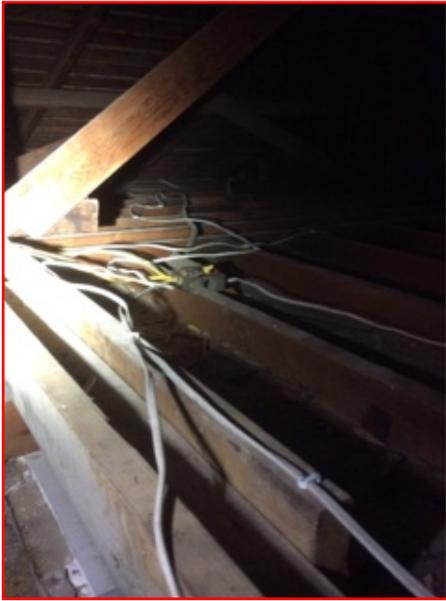
Figure 14-1

13) Covers are needed on all junction boxes.

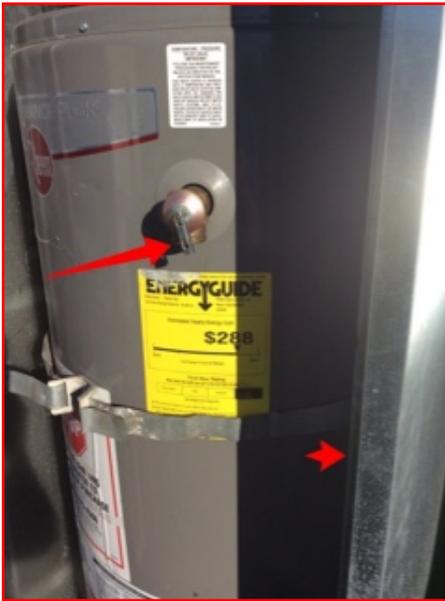
Figure 20-1

19) Blow off leg is not present from T&P valve. Copper leg needs to be installed.

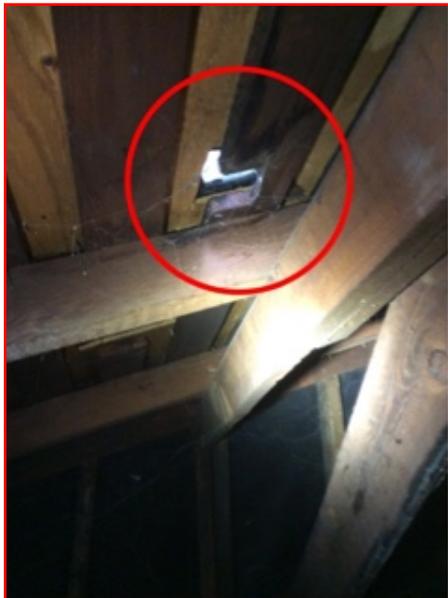
Figure 23-1

21) Open vent from previous drain line vent from bathroom. This is allowing water intrusion.

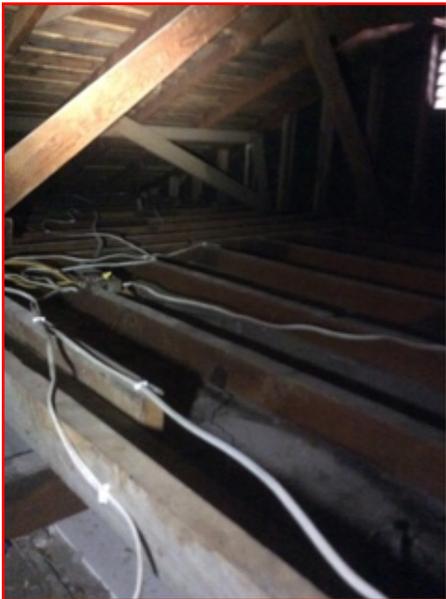
Figure 24-1

22) Insulation needs to be installed in attic.

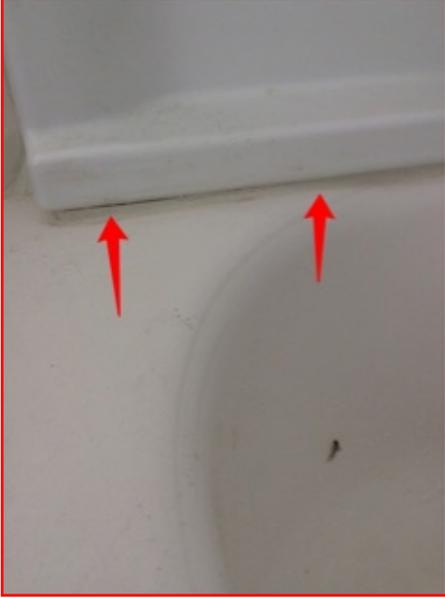
Figure 28-1

26) Water seal is needed around tub edge.

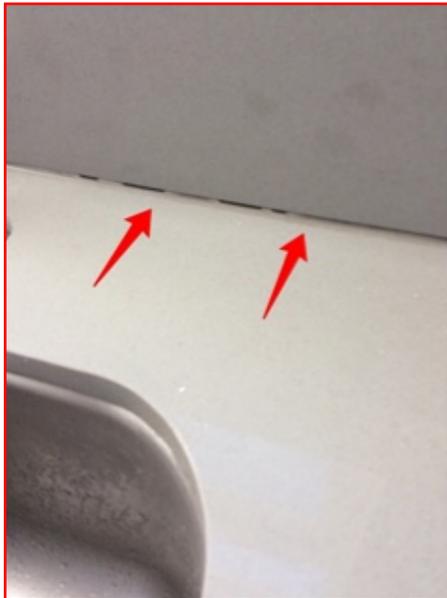
Figure 31-1

29) Water seal is needed behind sink to prevent water intrusion.

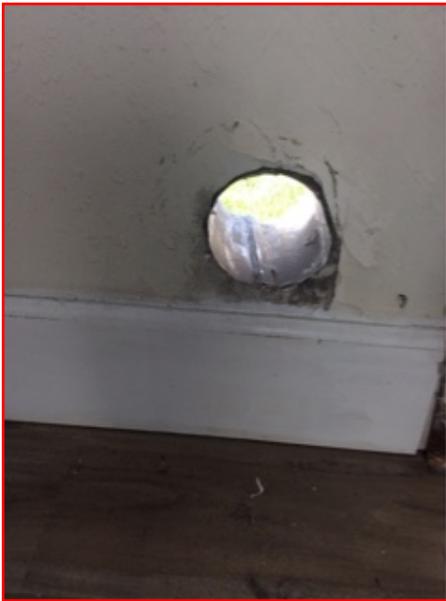
Figure 32-1

30) Dry vent needs a screen to prevent animal intrusion.
