# Your Inspection Report

## Sample Report West St. Paul, MN

**INSPECTION DATE:**  
Monday, June 2, 2014

RE: Report No. 1205, v.8  
Sample Report  
West St. Paul, MN

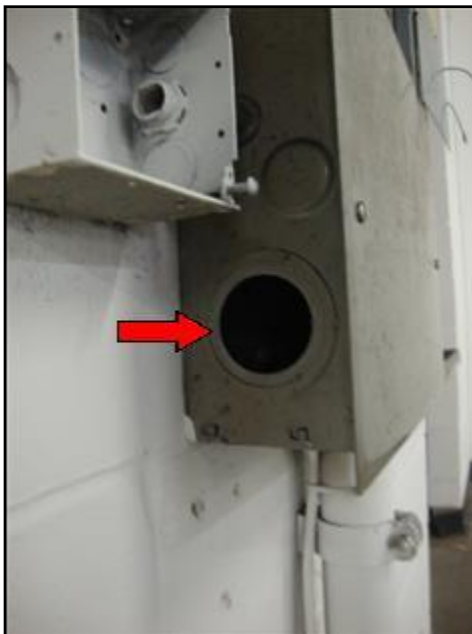
*Unprotected openings*

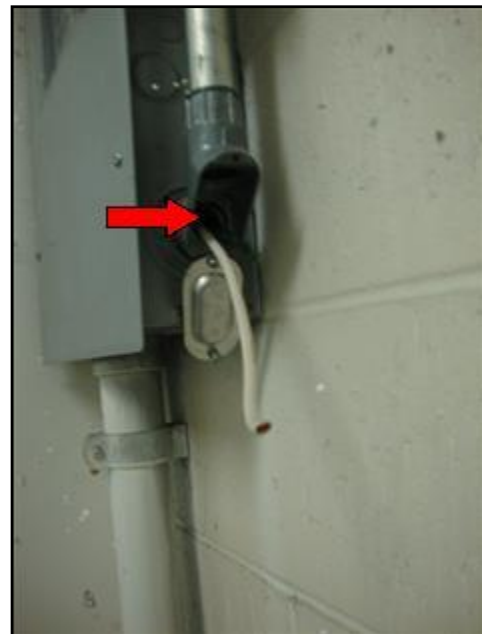
*Unprotected openings*

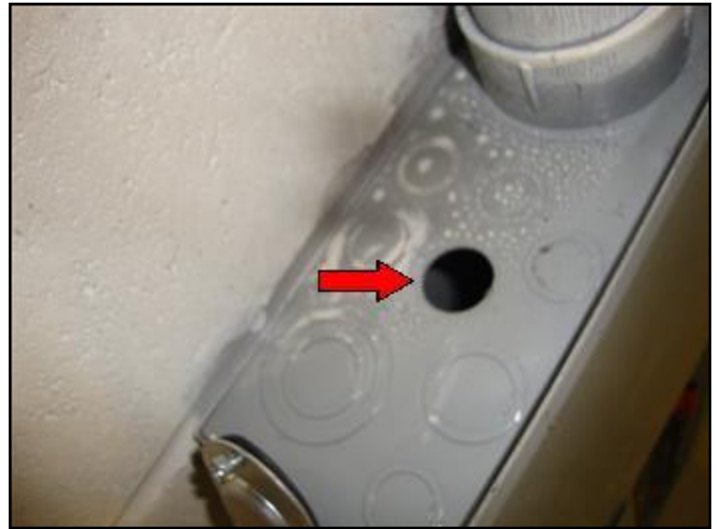
*Unprotected openings*

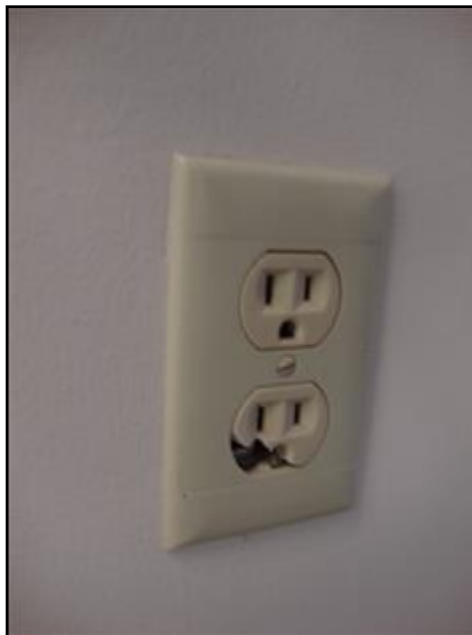
**9. Condition:** • Electrical outlets in close proximity to a water source

Exterior outlets and outlets located near utility or kitchen sinks are not GFCI protected.

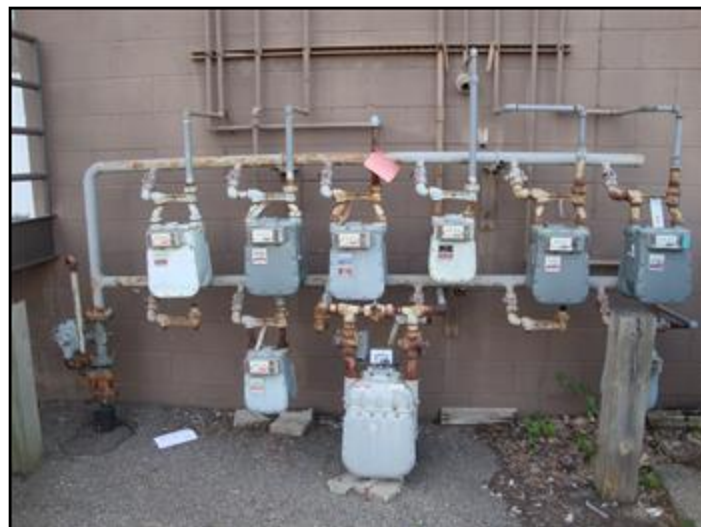
**14.** • Gas meter connection missing proper plug. Operating the valve has the potential to create a major gas leak.

**Task:** Repair

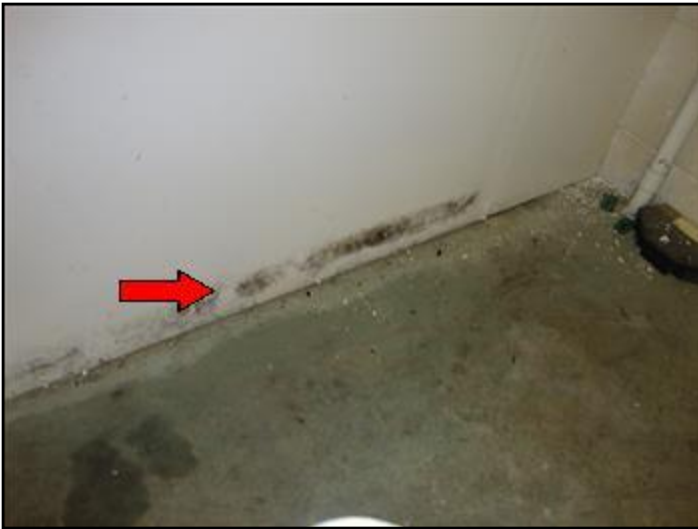
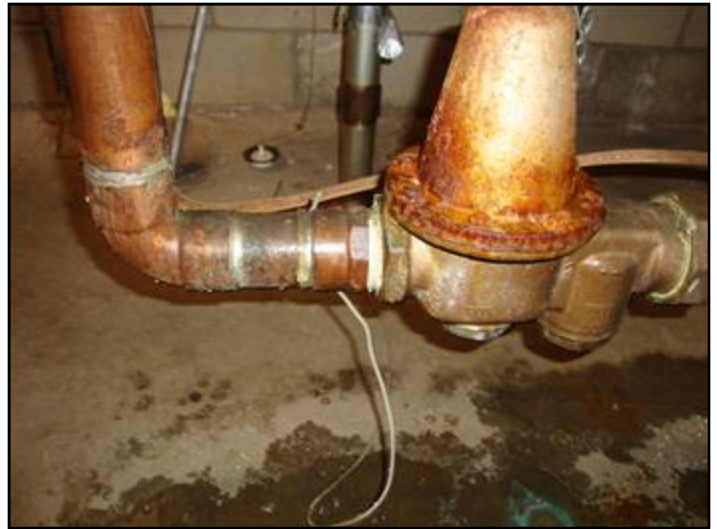
35. **Condition:** • Leaking shut off valve in suite PQ women's room.

**Task:** Repair

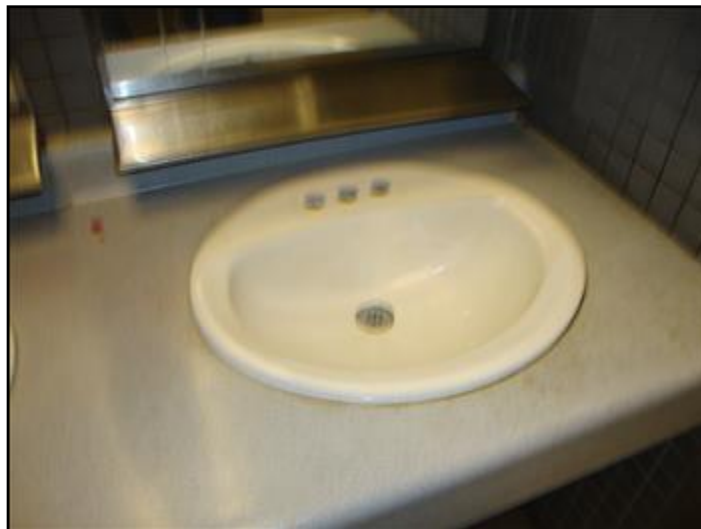
**43. Condition:** • The leaking faucet requires repair

**Location:** Suites PQ and EO

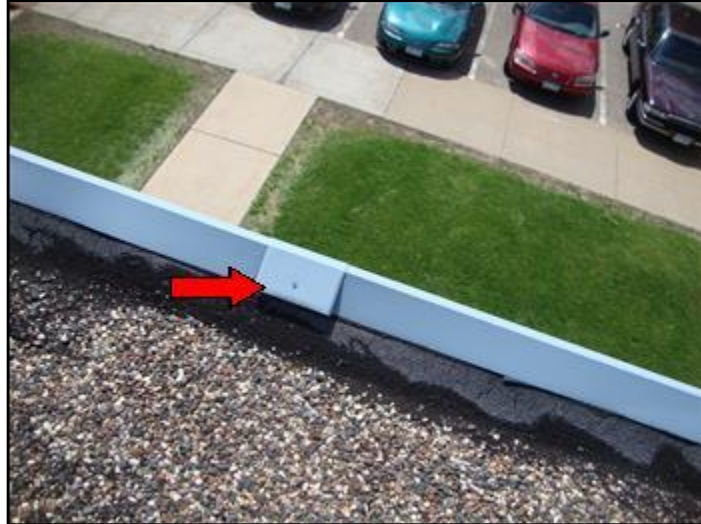
*Loose*

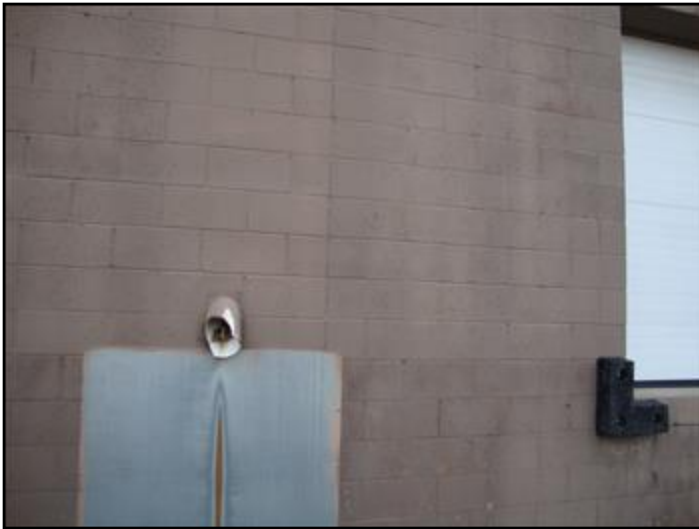
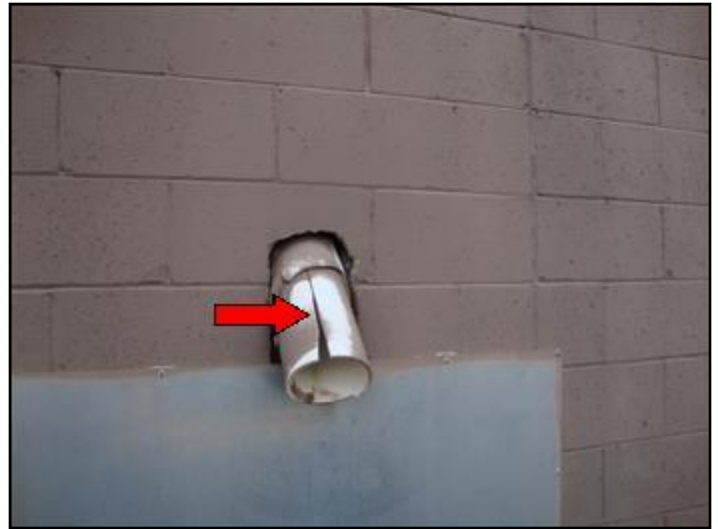
**56. Condition:** • Replace metal guard in area where block has deteriorated. Further deterioration is likely if guard is not replaced.

**Location:** South rear wall

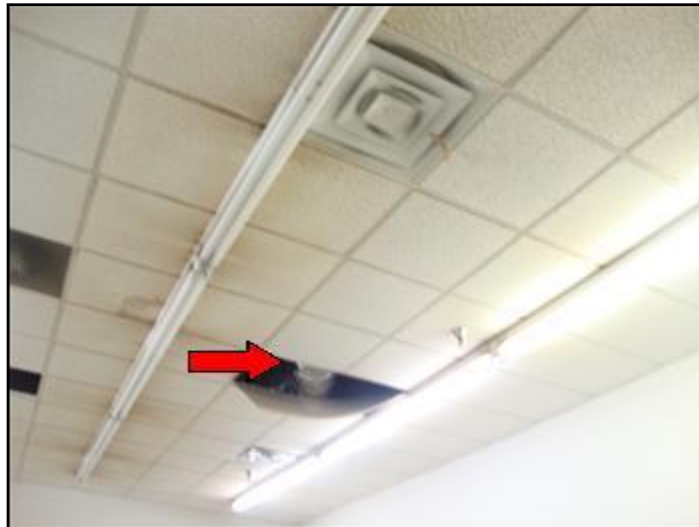
**59.** • Water damaged surfaces should be repaired and are expected to cost less than \$1,000. Carpet and flooring may need replacement and is estimated to cost between \$3 and \$4 per square foot installed for better quality material.

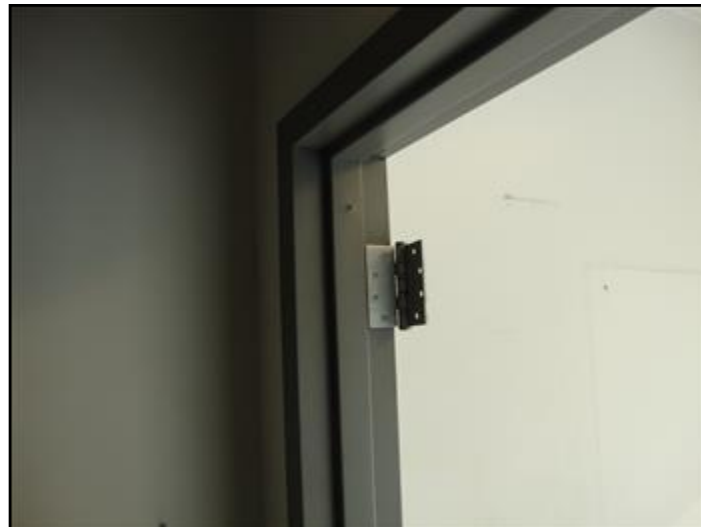
**64. Condition:** • Loose door knob. Storage room door.

**Task:** Repair

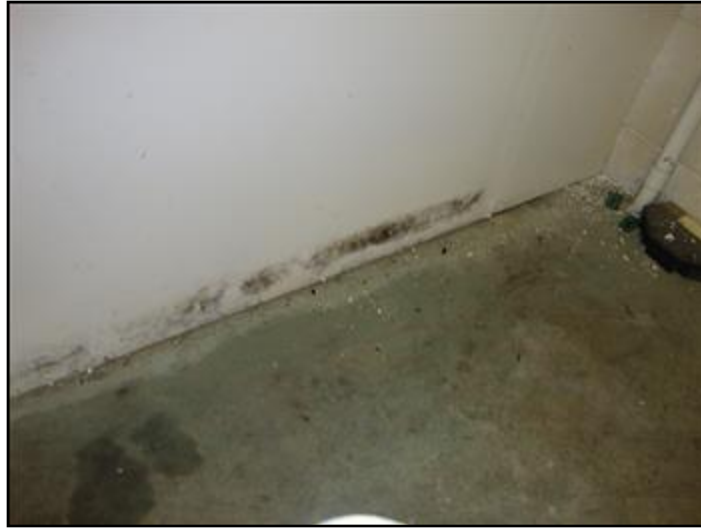
**69. Condition:** • Potential mold or mildew on drywall near the mechanical room entrance.

**Task:** Repair or replace

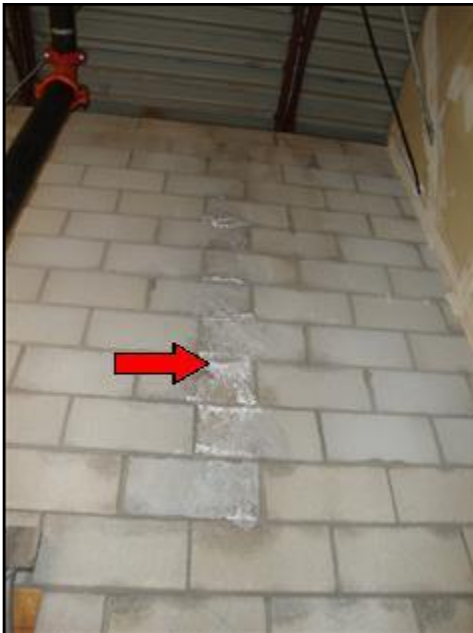
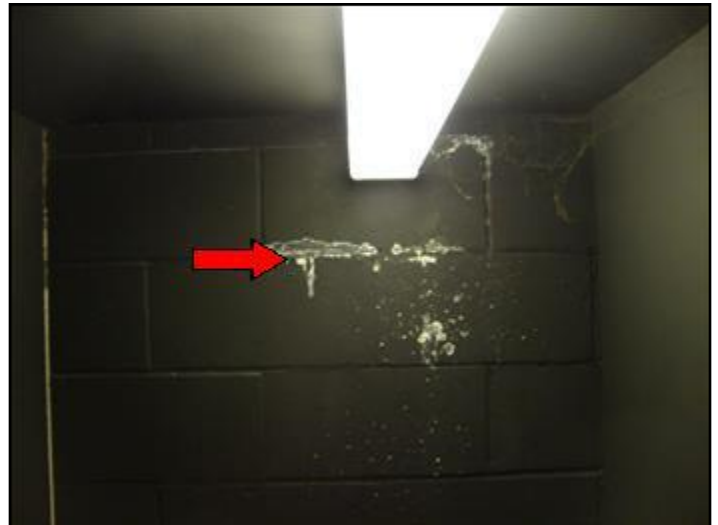
**70.** • Efflorescence and stains observed on rear warehouse walls and rear mechanical room wall.

**Task:** Monitor

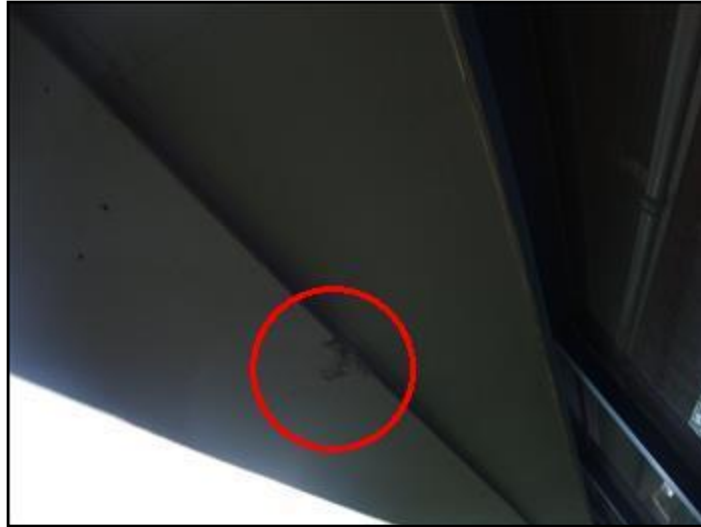
**79. Condition:** • Minor spalling or cracks observed on exterior concrete beam.

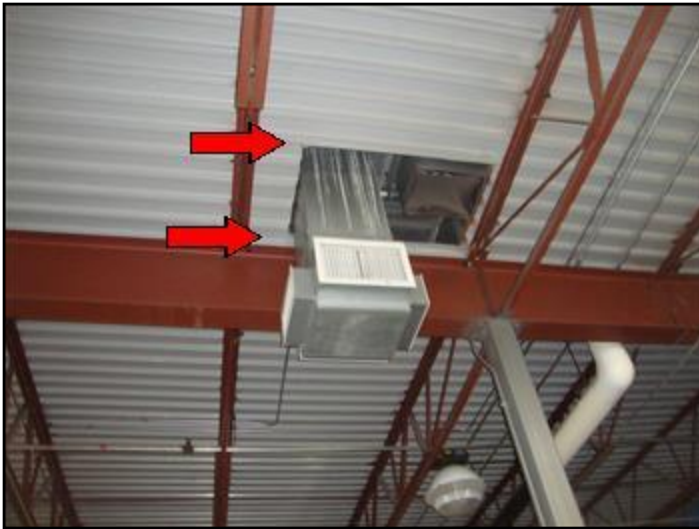
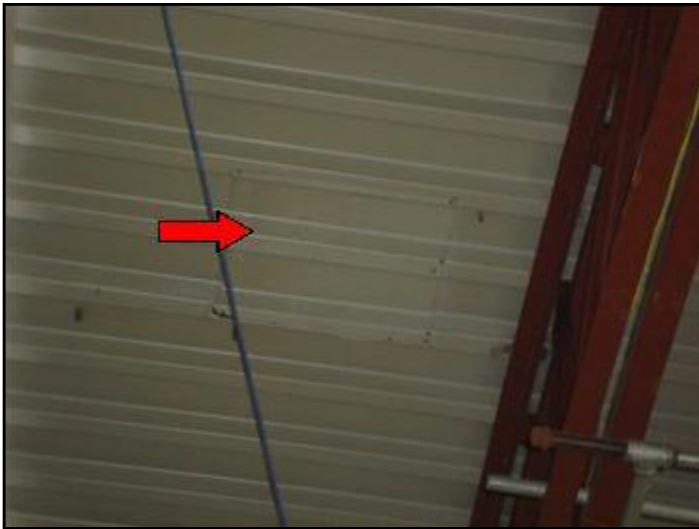
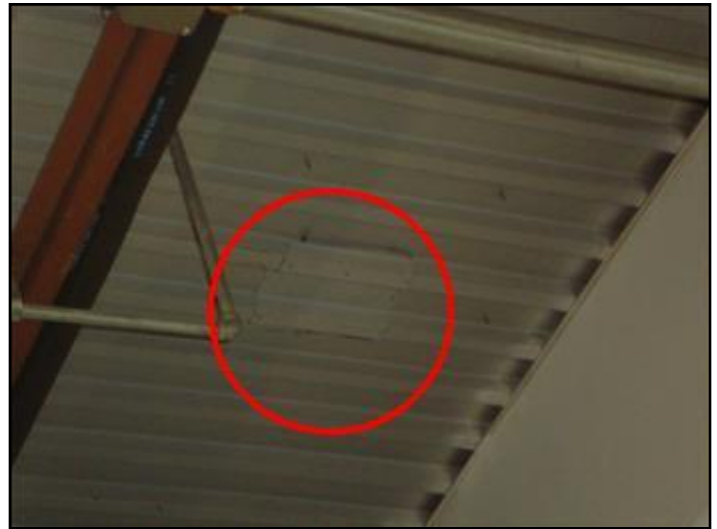
**83. Condition:** • Surface corrosion of the steel roof deck was noted  
Minor surface rust was observed in a few areas and was not widespread. Roof deck was in overall good condition.  
**Location:** Various  
**Task:** Monitor

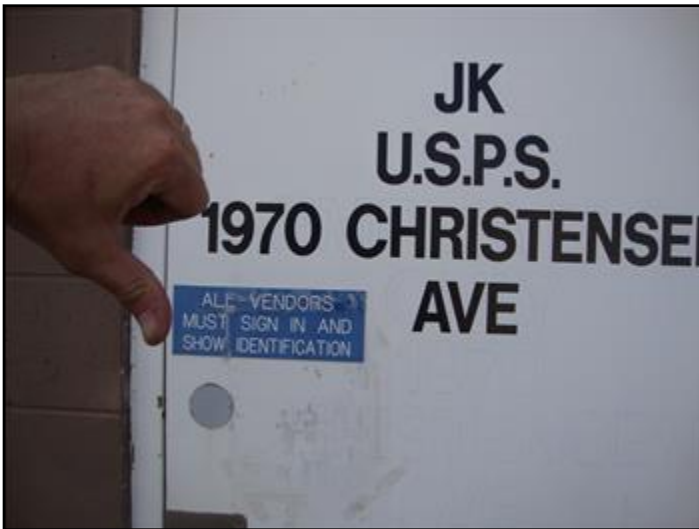
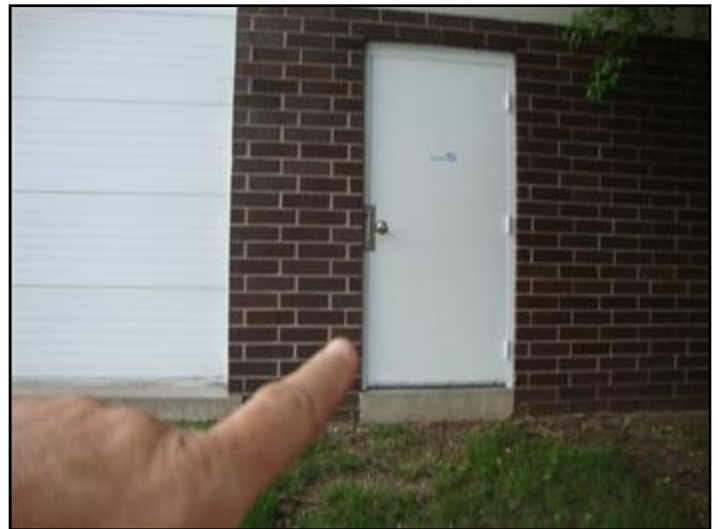
**92. Condition:** • Surface rust on fire escape doors.

**Task:** Repair

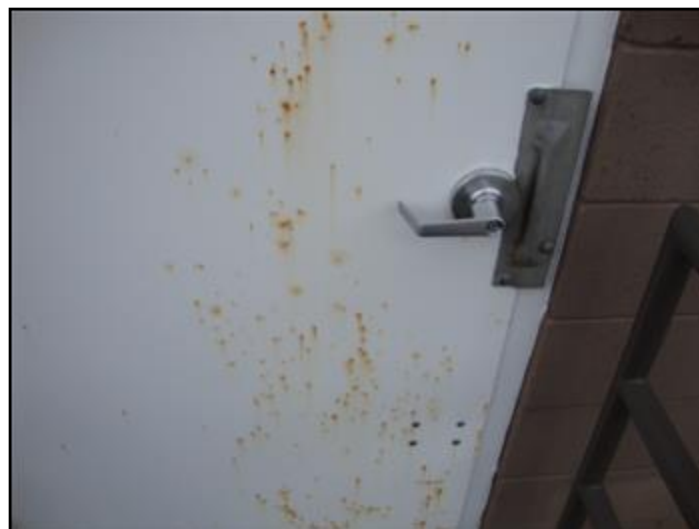
**93. Condition:** • Rotted plywood

Replace plywood and paint.

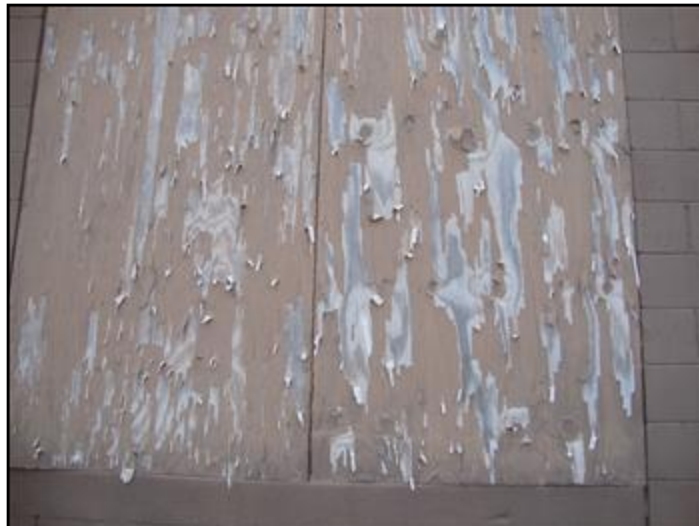
**94. Condition:** • Delaminated plywood

*Delaminated plywood*

Replace damaged plywood and paint.

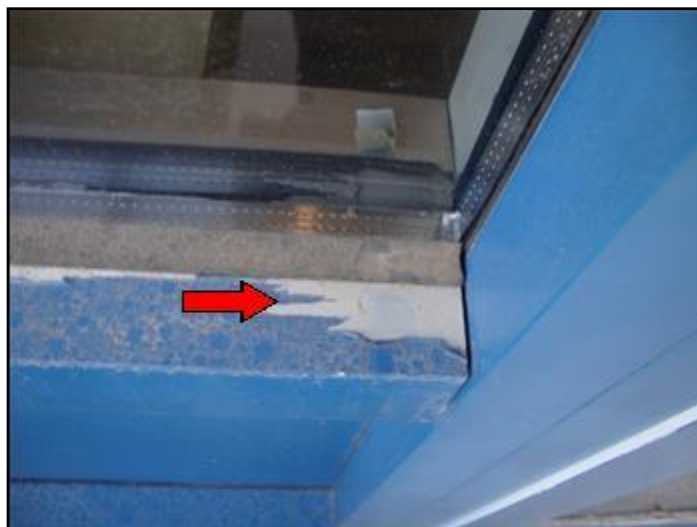
**97. Condition:** • Minor paint deficiencies observed on window frames.

**Task:** Repair

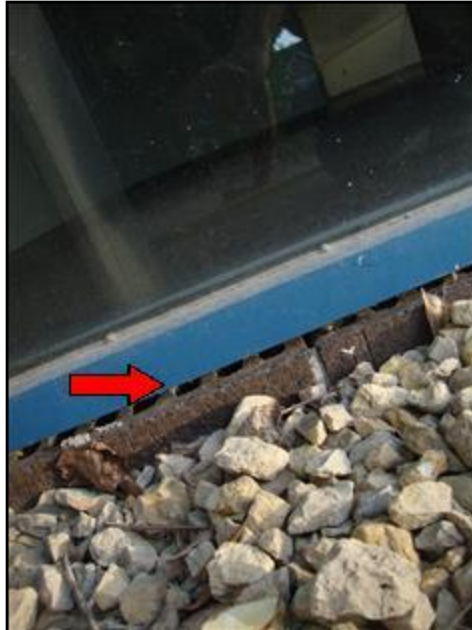
**100. Condition:** • Missing caulking

Window frames at grade at various areas in the front of the building lack caulk or weather stripping. The condition appears to be worse at the north end of the building.

*Missing caulking*

**Task:** Repair

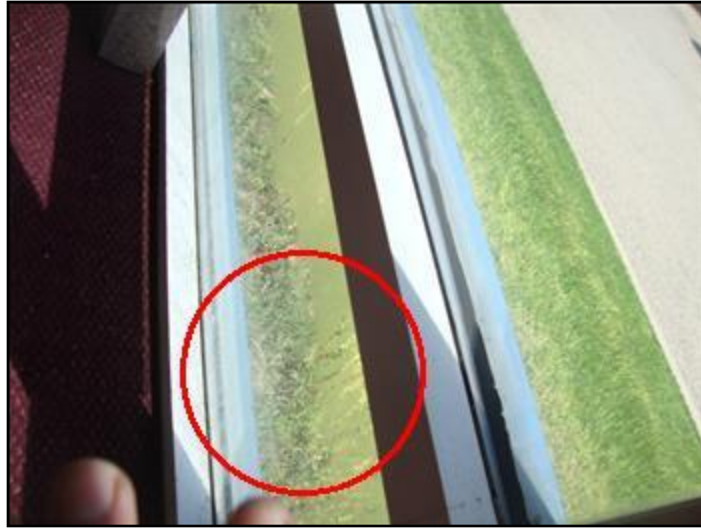
**102. Condition:** • A lost seal has resulted in the formation of condensation between the glazing

*A lost seal has resulted in the formation...*

**Task:** Repair

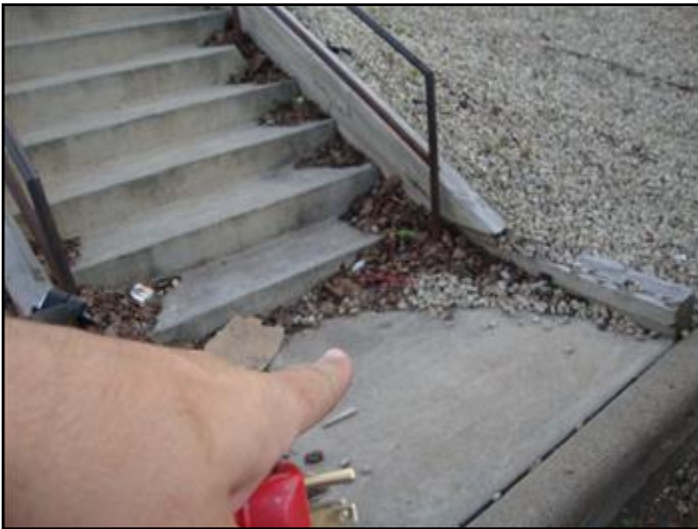
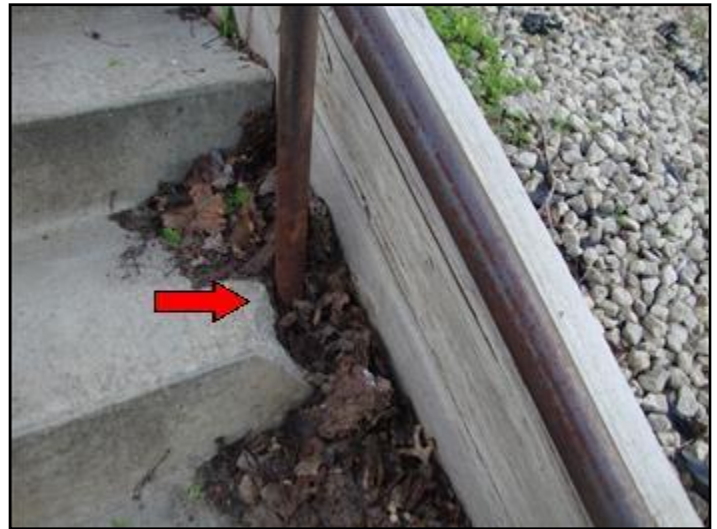
**103. Condition:** • Landing settled at steps. Damaged concrete when railing is anchored to steps.

**Task:** Repair

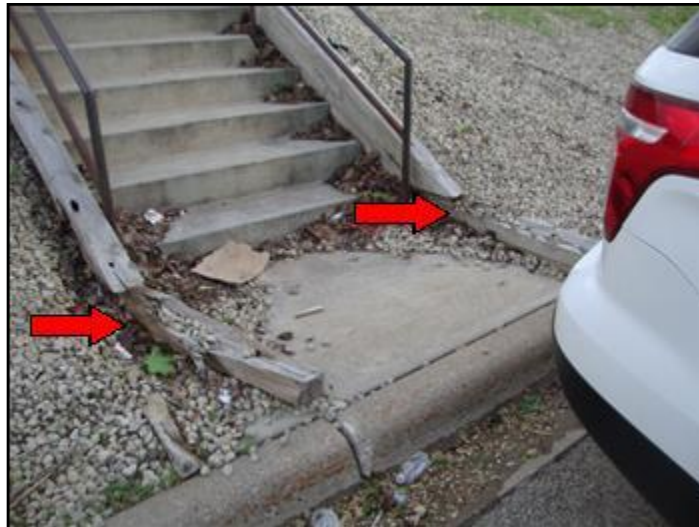
**110. Condition:** • Deteriorated

*Deteriorated*

**Task:** Repair
